CORNER RECORD

Document Number 176

Section 19, T. 22 N., R. 13 E., M.D.M.

County of Plumas, California

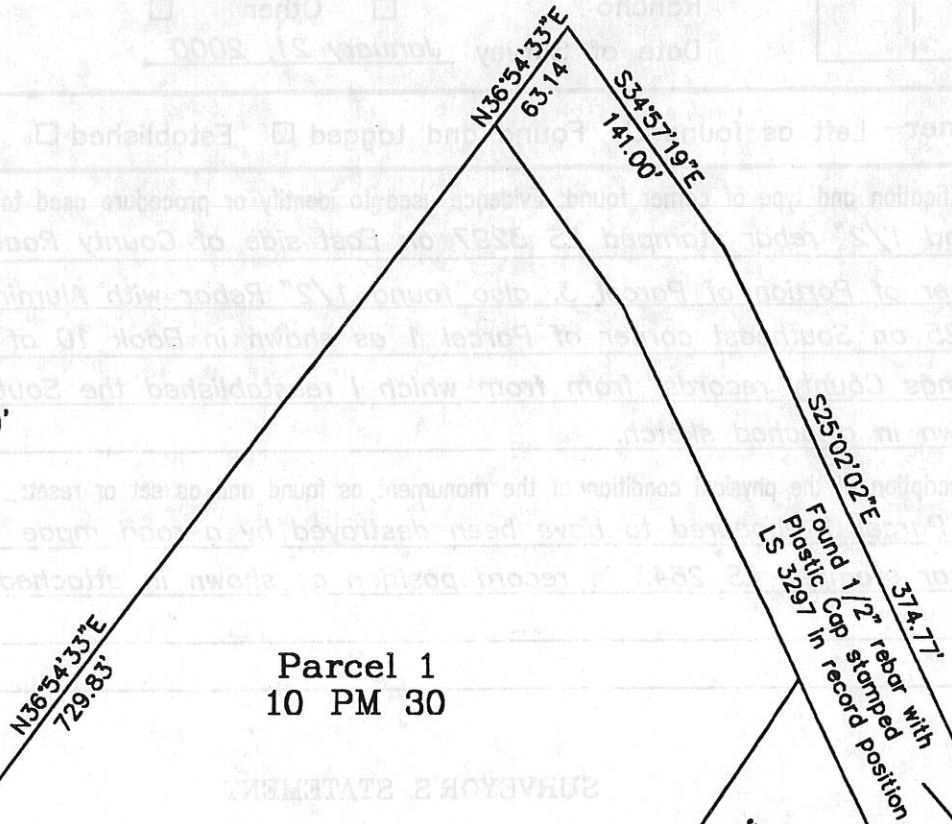
A description of the physical condition of the monument as found and as set or reset: The Southwest corner of Parcel 1 appeared to have been destroyed by a road made for power line. Set 5/8" rebar stamped LS 2843 in record position as shown in attached sketch.

Note: 10 PM 30 shows this line as N76°42'14\"E, calculations show this to be S76°42'14\"E.

Found 1/2" rebar with Aluminum Cap stamped RCE 13225 per 10 PM 30 in record position.

Found 1/2" rebar with Plastic Cap stamped LS 3297 in record position

Found 1/2" rebar with Aluminum Cap stamped RCE 13225 about 2.5' out of ground on steep bank, did not use for control.

Set 5/8" rebar with Aluminum Cap stamped LS 2843 in record position.
