Hispanic Tree Trimmer Killed After Being Pulled into A Wood Chipper

August 30, 2004

Investigation: # 03-NJ-042

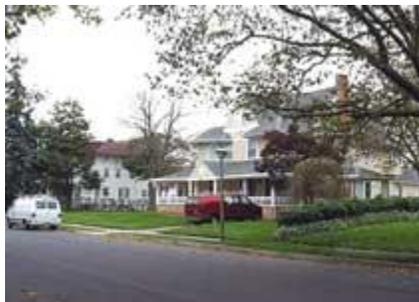
Photo 1. Site of Incident

The incident occurred on the street in front of a large home in a residential suburban neighborhood. The homeowner had recently purchased the house and was renovating it to move in for the upcoming summer. As part of the work, he had contracted with the tree-trimming company to remove two trees from the side yard of the house: a dying 25-foot-tall maple and a second, smaller tree that was to be removed for aesthetic reasons. A limb was also to be cut down from a third tree. On Saturday, June 13, 2003, the workers went to the property and cut down the trees, planning to return the next day to clean up the debris.

The incident occurred on Sunday, June 14, 2003. A crew of seven workers met at the site and started work at 8:30 a.m. All were family members of the two partners: three cousins, one uncle, and one brother-in-law. They set up a wood-chipping machine at the curb in front of the house and started dragging the brush, branches, and trunk wood to the machine. The wood chipper was a diesel-powered machine towed to the jobsite by a box truck (see [Photo 2](#)). The machine accepted brush and wood up to 12" in diameter through a large hopper at the rear of the machine. When wood and brush were pushed into the hopper, two rotating feed wheels took hold of the material and directed it against the cutting knives on a rotating disk, quickly reducing the wood to small chips. The chips blew out through a chute where they were collected in the back of a box truck.

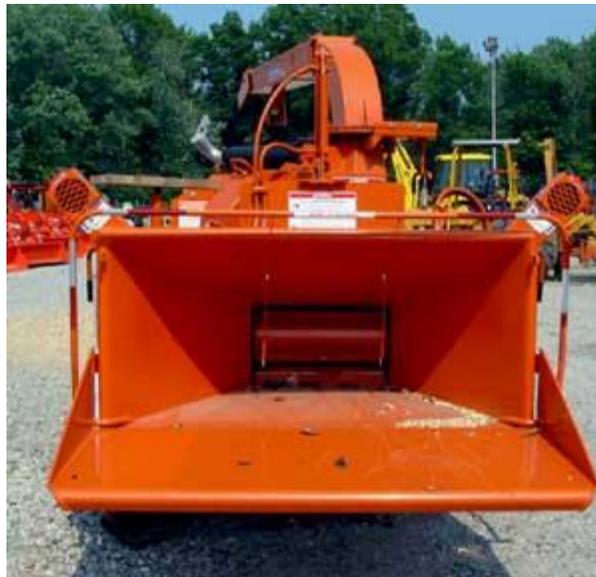
During the cleanup the crew worked as a team; no one acted as a supervisor. At about 10:40 a.m., the victim walked to the chipper carrying an armload of branches and brush. One of the company owners was standing behind him, waiting his turn to put a load in the hopper. The owner stated that part of the victim's load was a section of the tree's top that was approximately eighteen inches long and three to four inches in diameter. The section had small stumps projecting from it where small branches had been cut off. After putting the load in the hopper, the victim held onto the top of the chipper and used his foot to push the load into the feed wheels. As he did so, one of the small branch stumps projecting from the tree section caught his sneaker. The feed wheels took hold of the trunk section, pulling the trunk and victim into the chipping knives.

**Photo 3. New chipper showing feed wheels,
hopper feed table, and emergency stop pull
cords in hopper.**

It was noted that the manufacturer's website recommended a number of procedures and machine modifications for preventing injuries. This included using of a push stick to push materials into the hopper and training employees to use the bar that reverses the machine.

Discussion: The wood chipper involved in this incident was an older model machine that was purchased in used condition by the company. This machine did not have a number of safety improvements that were included in later models, including a feed table that prevents workers from getting too close to the feed wheels, and emergency pull cords that reverse the feed wheels (see [Photo 3](#)). These devices may have prevented the victim from kicking the brush into the hopper. NJ FACE recommends that machine owners should contact the equipment manufacturer or dealer to ask if safety modification kits are available. The equipment dealer for this machine stated that the manufacturer provides free update kits for older machines. The manufacturer would send the kit to a service representative, who would charge only for the labor to install it on the chipper.
