## CORNER RECORD

Document Number 100Portion of Section 6, T. 23 N., R. 14 E., M.D.M. County of Plumas, CaliforniaBrief Legal Description Southwest corners of Lots 66, 67, 68 and point of slope easement between Lots 68 and 69, Crocker Mountain Estates, 3 M 44

Lots 66, 67, 68 & 69  
Crocker Mountain  
Estates

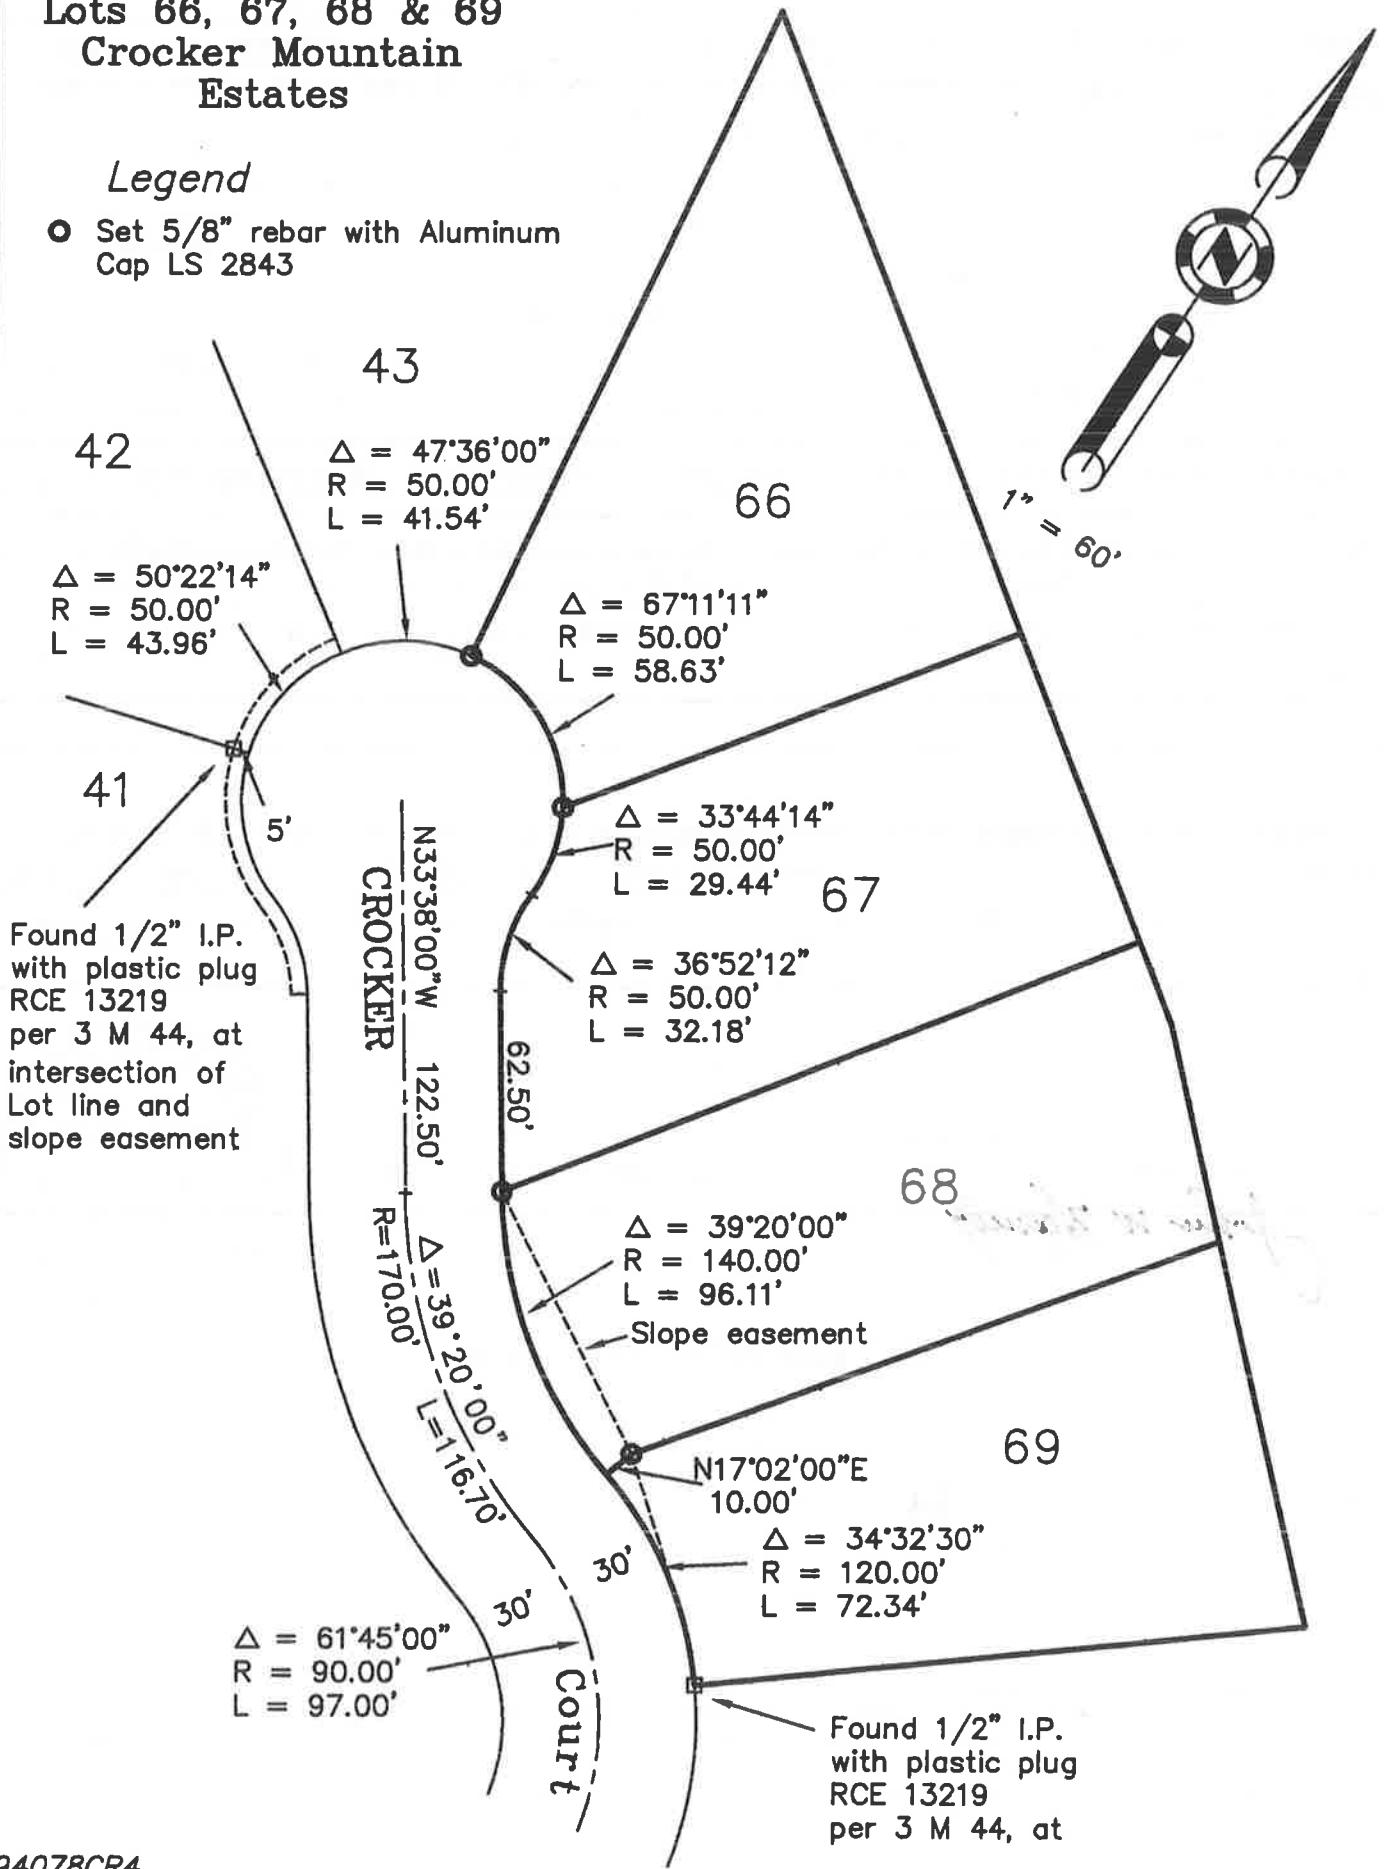
Identification and type of corner found: Evidence used to identify or procedure used to establish or reestablish the corner. Found 1/2" I.P. at most Southerly corner of Lot 69 and at point of slope easement between Lots 41 & 42 at record positions. All other corners which were missing fell on steep cut banks.

A description of the physical condition of the monument as found and as set or reset: Set 5/8" rebar with aluminum cap LS 2843 at the Southwest corners of Lots 66, 67, 68, and point of slope easement between Lots 68 and 69. at record position between found corners as shown on sketch.
