Additional Information Parcel Map for Randy Barlow

A Division of the Parcel

Described in Document 2017-0002969, Official Records
Situate in the SW 1/4 of the NE 1/4 Section 16
Township 24 North, Range 9 East, M.D.M.

SHEET 2 OF 2

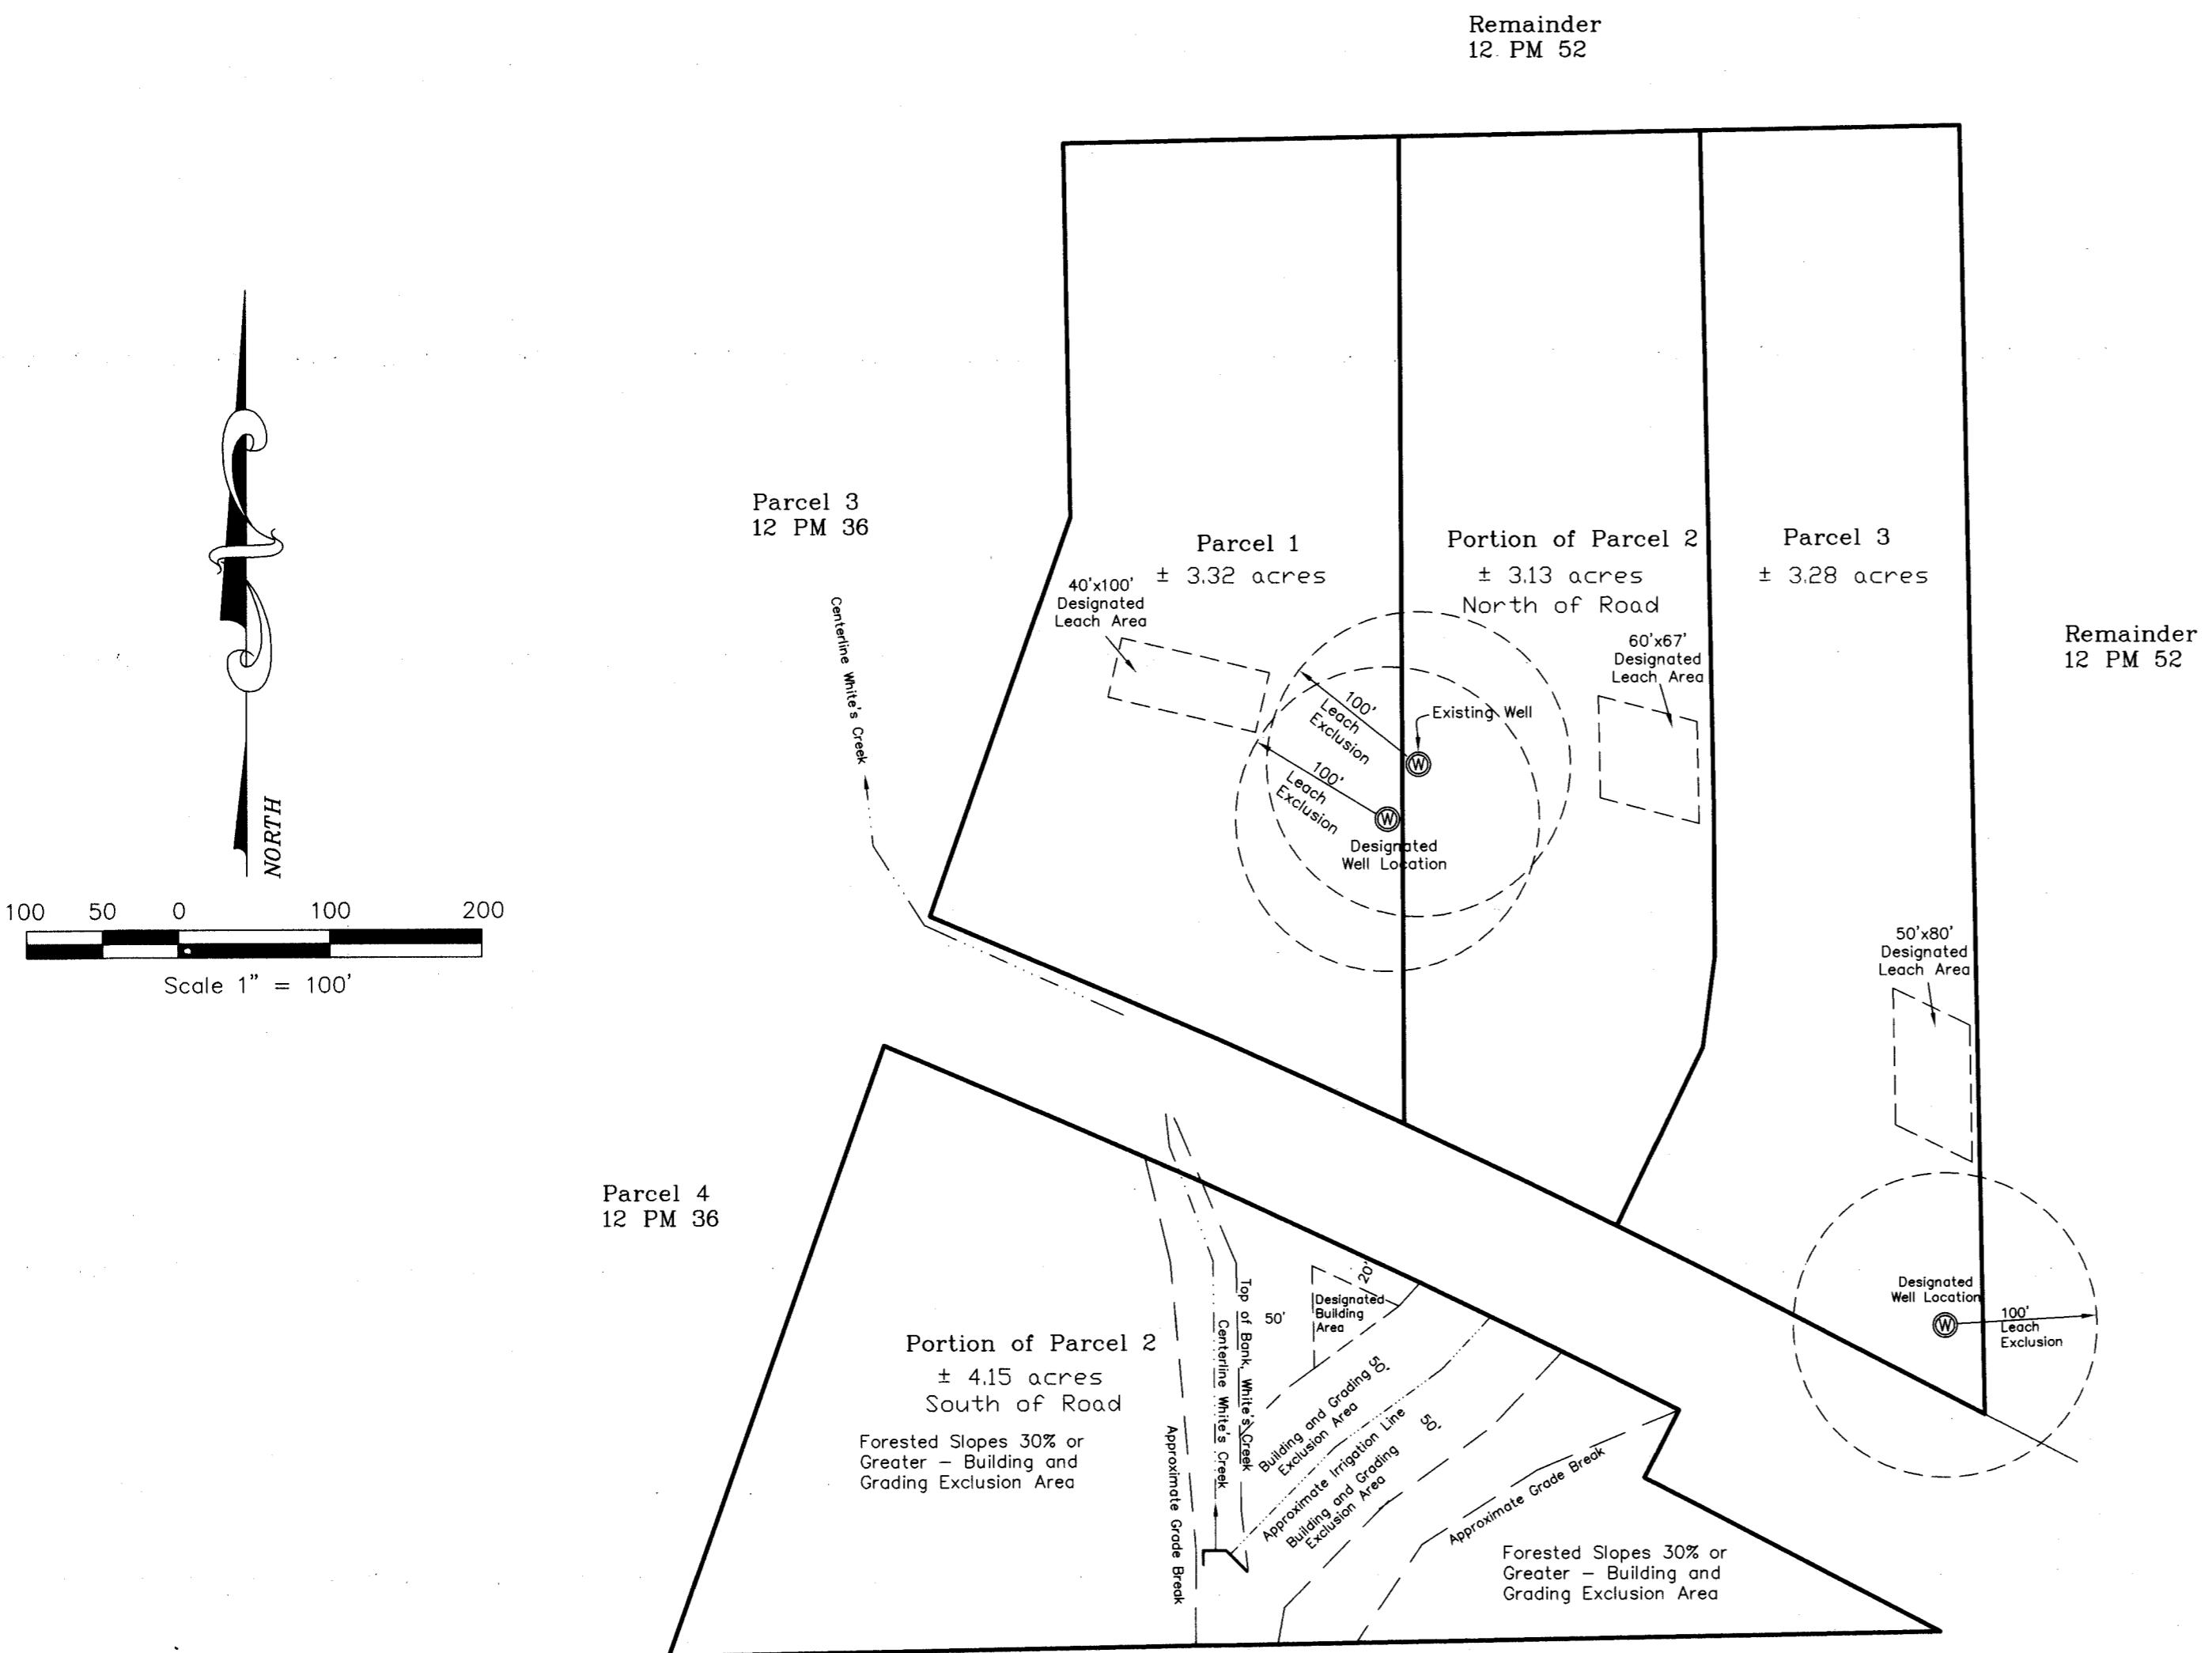
3. Prior to grading or development on the portion of Parcel 2 lying south of Bucks Lake Road, a grading and drainage report, reviewed and approved by Plumas County Department of Public Works, shall be required. Drainage infrastructure improvements, including a pro-rata share improvement to the existing culvert on Bucks Lake Road that carries storm water from said lot, may be required.

5. The structure known as Feature 1 of CA-PLU-6457H (the red hay barn) shall be protected from demolition, destruction, adverse alteration, or re-location. Additional, Feature 3 of CA-PLU-6457H (the stock barn with painted flag) shall be protected from demolition, destruction, adverse alteration, or re-location as well.

Designated sewage disposal areas may be relocated with approval of the Environmental Health Department.

Designated well locations may be relocated with approval of the Environmental Health Department.
