**Mitigated Negative Declaration Number 687
For Special Use Permit U 7-24/25-01**

**Bucks Lake Trail System Project
Plumas County, CA**

Mitigate Negative Declaration Number 687

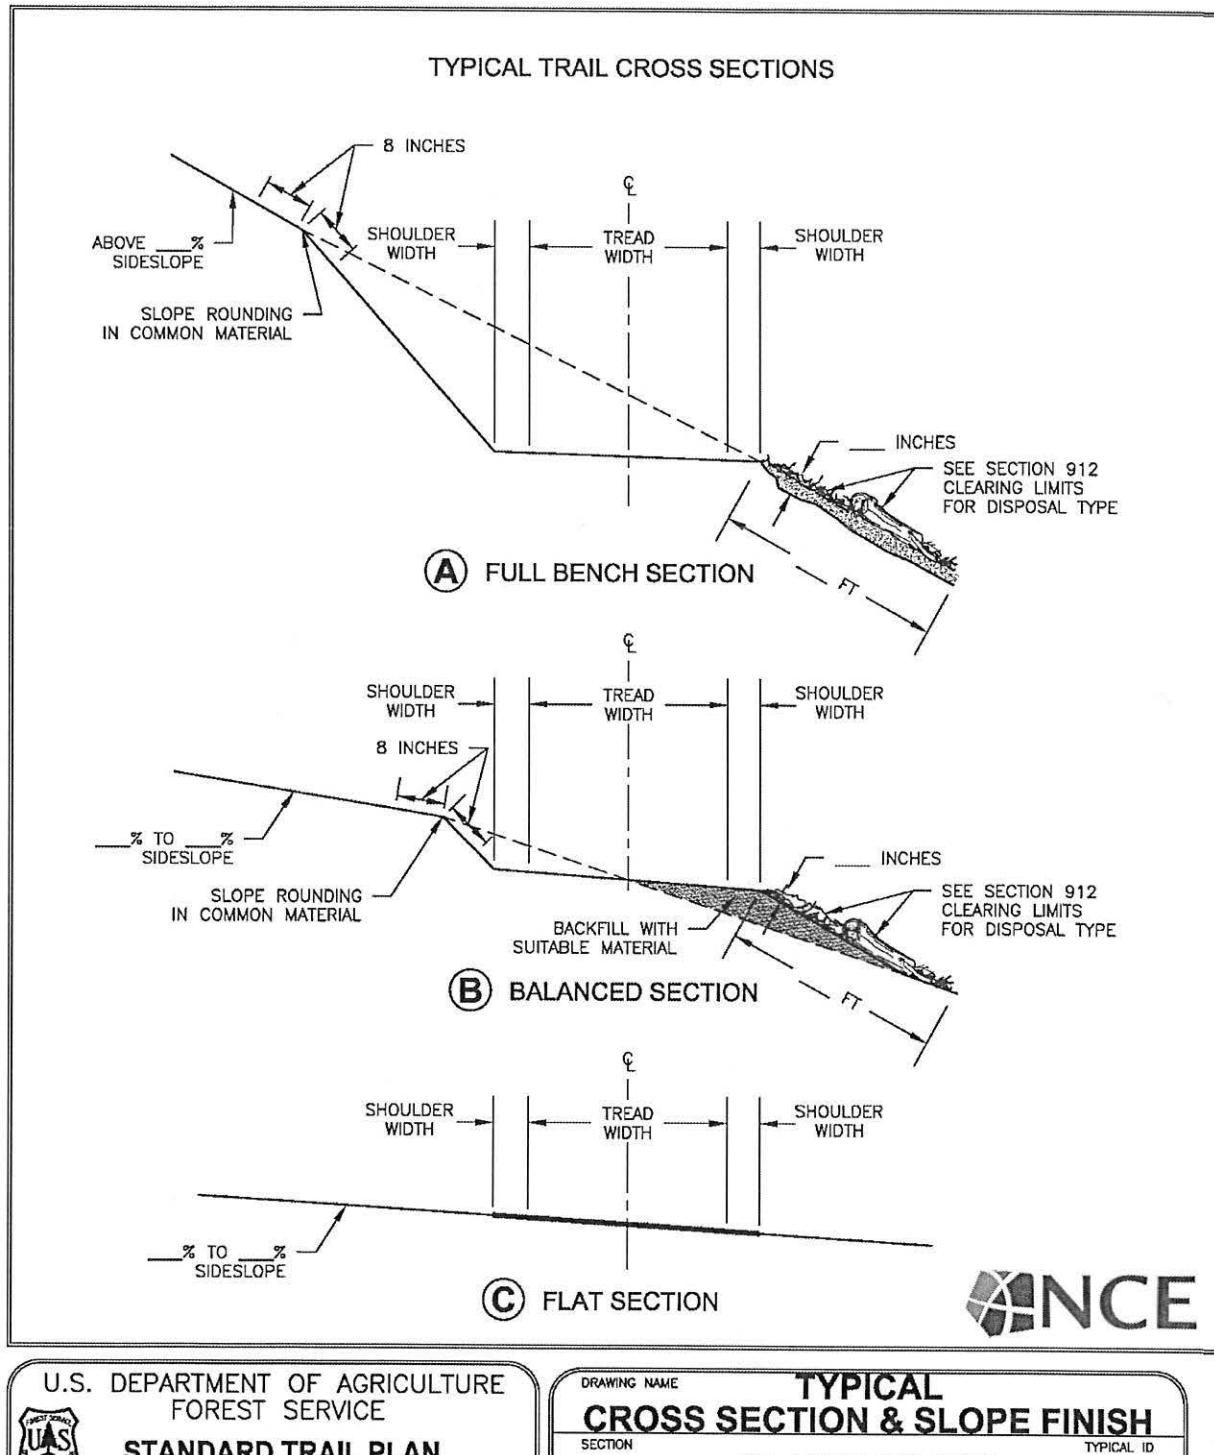
Figure 3. USFS Standard Trail Cross Section and Slope Finish

- The design cross-slope would be 5 to 8 percent with a maximum cross-slope of 10 percent.
- The maximum depth of excavation to construct the trail would be approximately 8 to 13 inches deep depending on the slope.
- Vegetation clearance would be to a height of 6 to 8 feet and would be 60 to 72 inches wide, providing a shoulder clearance of 6 to 12 inches. Short, light vegetation such as mosses, native grasses, ferns, and shrubs may encroach into the clearing area.
 - No trees larger than 6 inches in diameter would be removed and all vegetation would either be removed by pulling the root wad or by cutting flush with the ground.
- The design turning radius would be 3 to 6 feet.

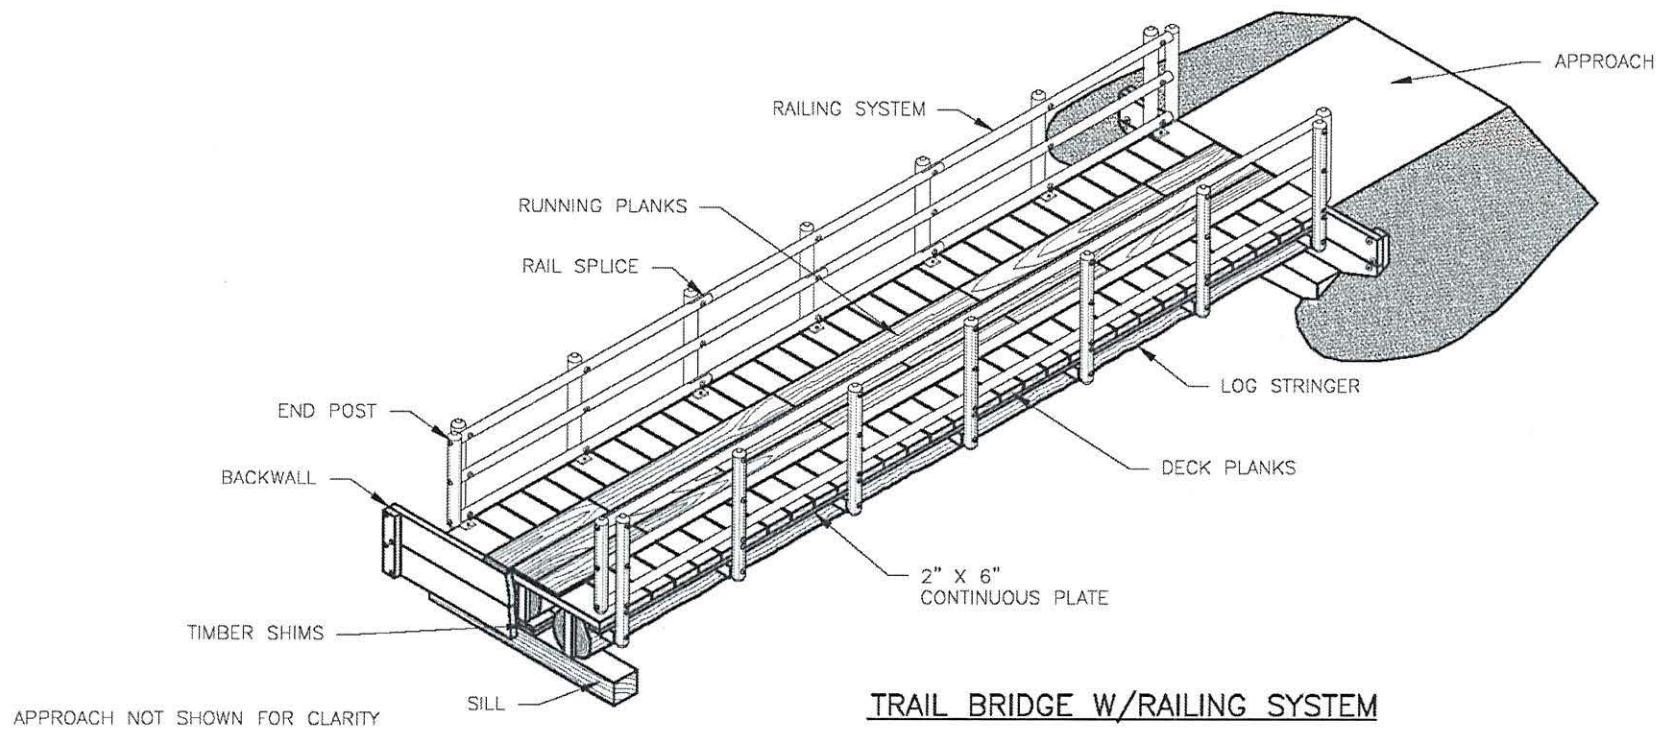
Figure 4. USFS Standard Multiple Log Stringer Trail Bridge

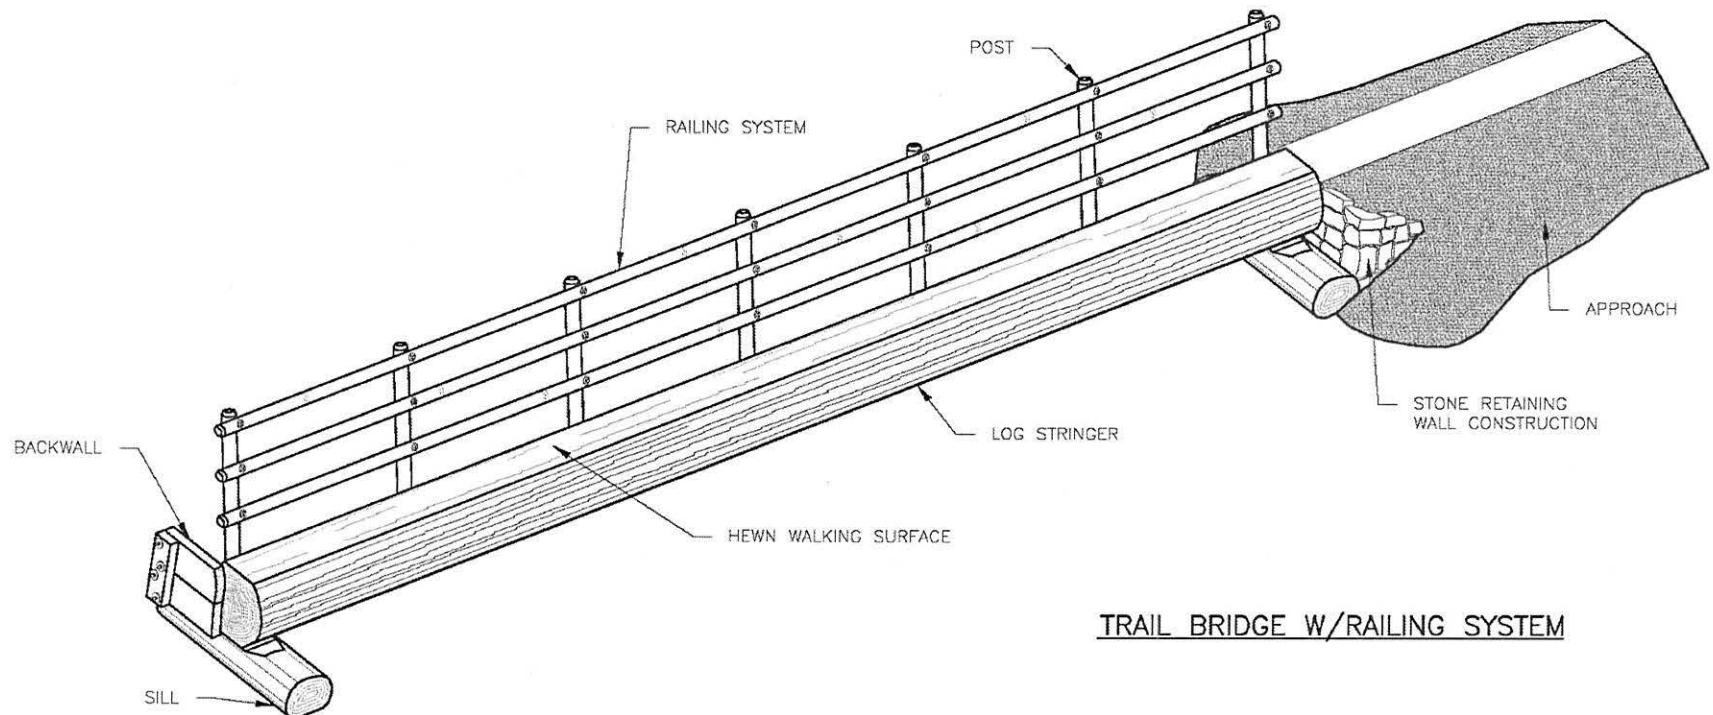
Figure 5. USFS Simple Stringer Bridges or Hardened Water Crossings

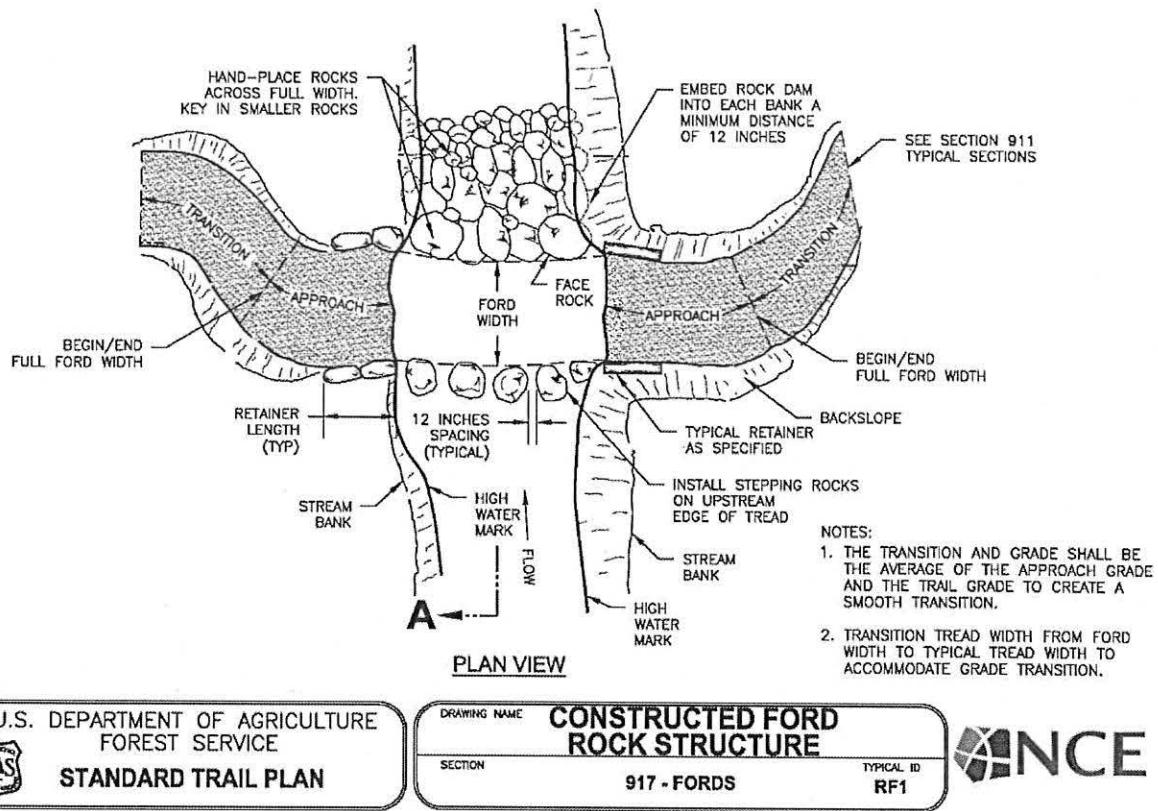
Figure 6. USFS Hardened Water Crossings

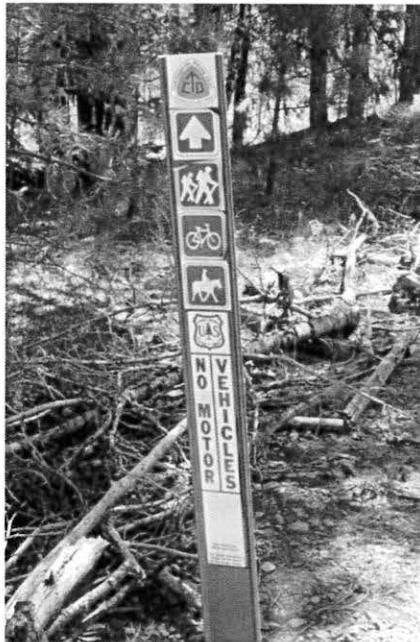
Figure 7. Carsonite Sign

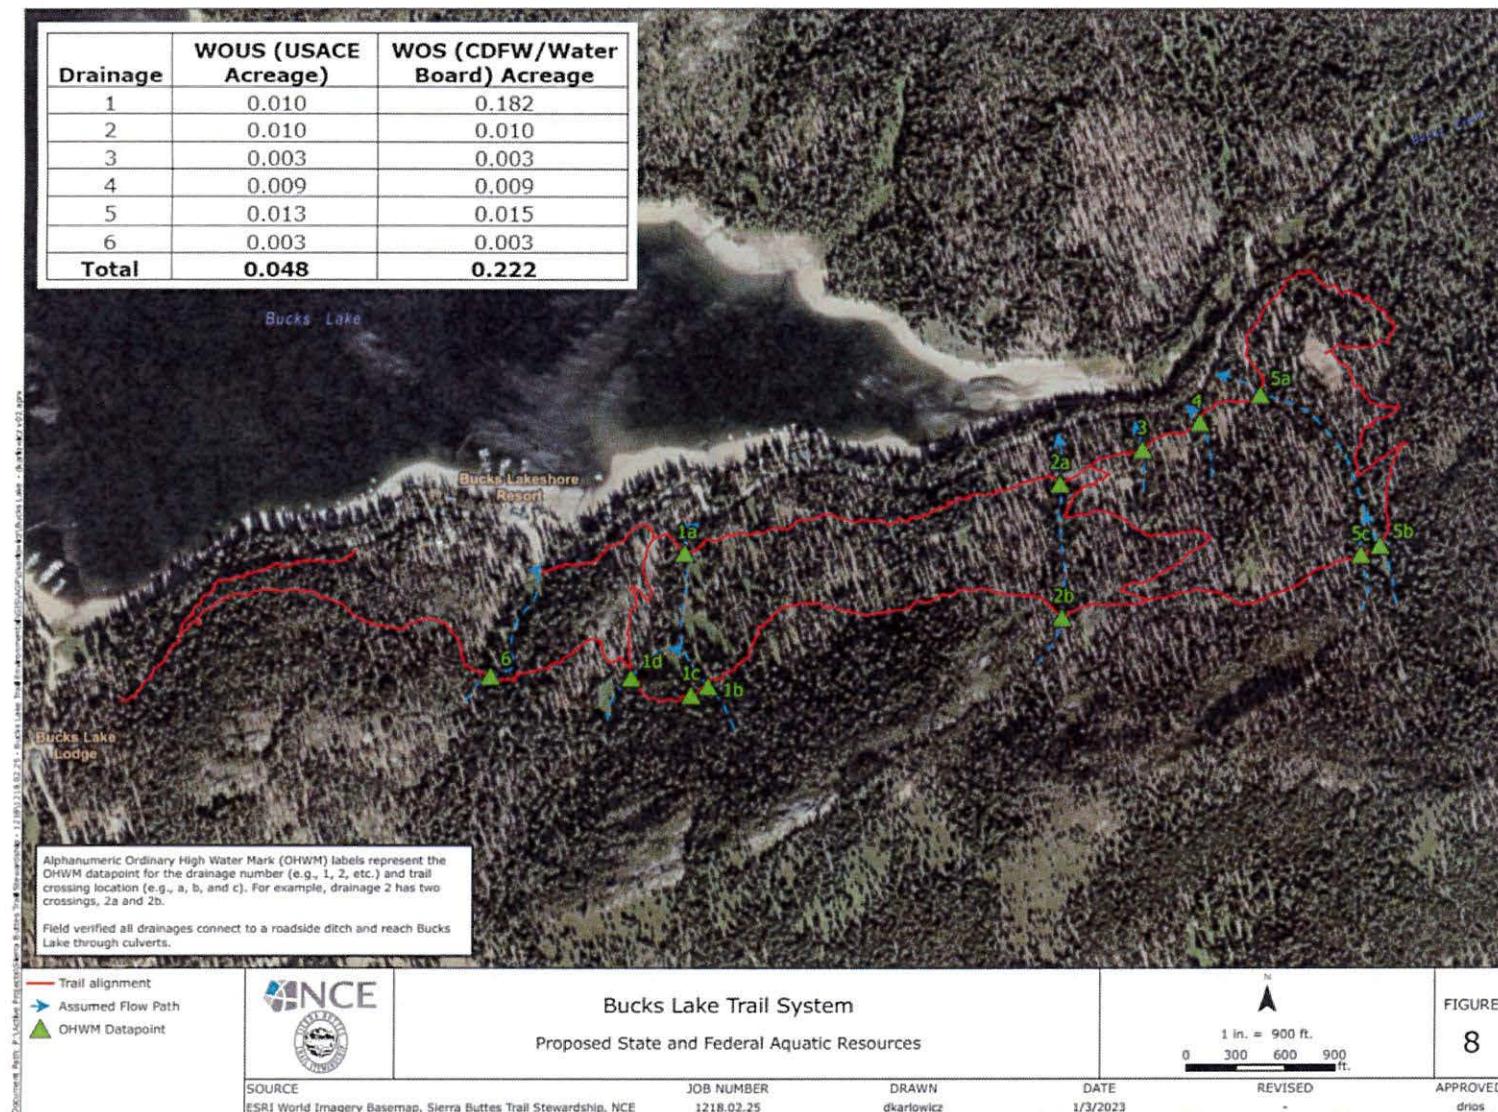
Figure 8. Proposed State and Federal Aquatic Resources (NCE 2023)

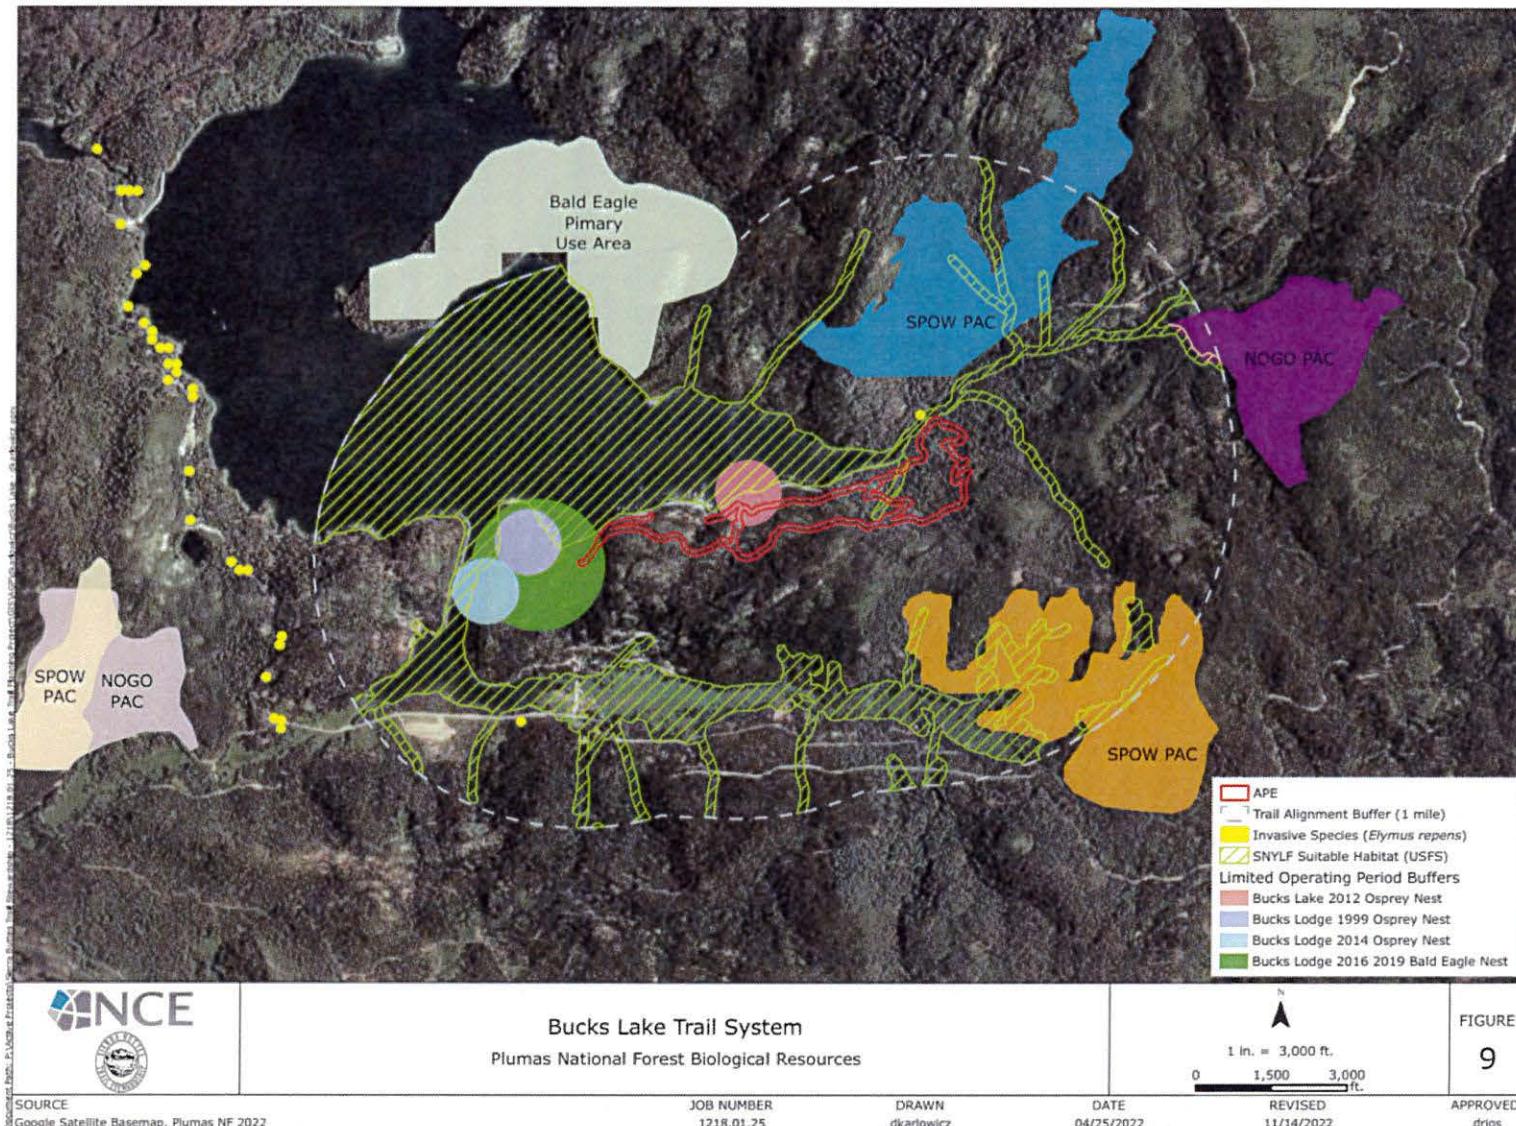
Figure 9. Plumas National Forest Biological Resources (NCE 2024a)

Results of the USFWS IPaC database search indicate that Foothill Yellow-legged Frog (*R. boylii*), Sierra Nevada yellow-legged frog, northwestern pond turtle (*Actinemys marmorata*), delta smelt (*Hypomesus transpacificus*), and monarch butterfly (*Danaus plexippus*) may be found in vicinity of the APE. There is a CNDDB record from 1991 of Sierra Nevada yellow-legged frog in Haskins Creek approximately 0.5 mile south of the APE. USFS-mapped suitable habitat and USFWS critical habitat for Sierra Nevada yellow-legged frog are present in the APE and overlap with the trail alignment (Figure 9).

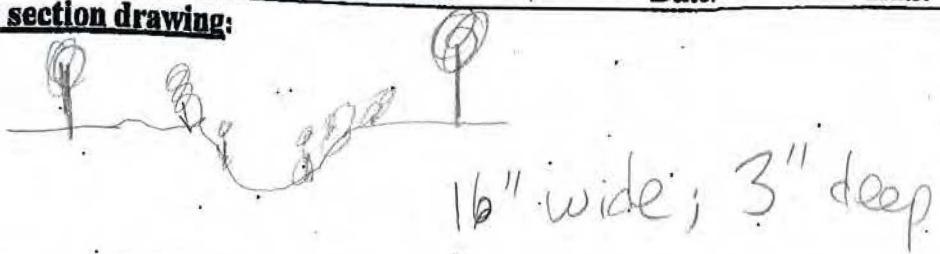
Cross section drawing:

GPS point: D9 This is now D1b

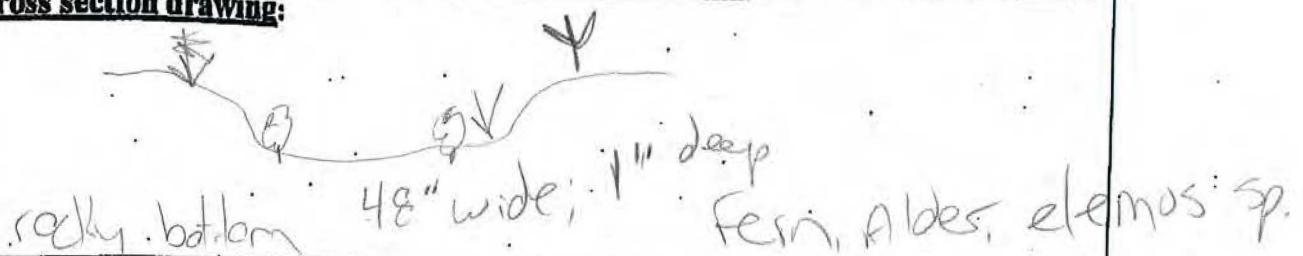
Cross section drawing:

GPS point: 0b This is now D5b

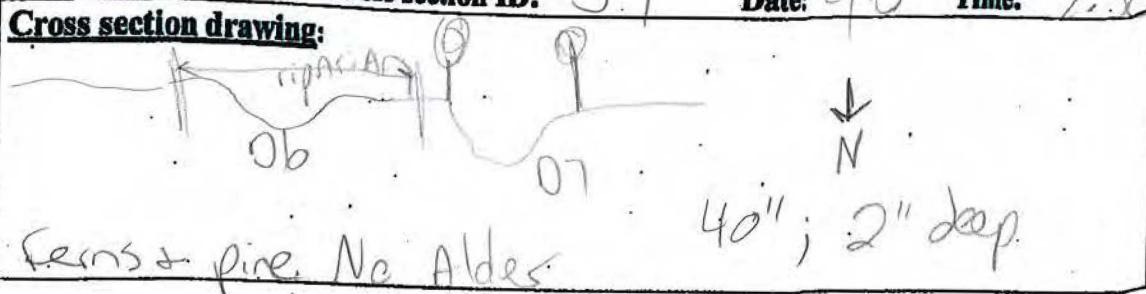
Cross section drawing:

GPS point: 07 This is now D5c

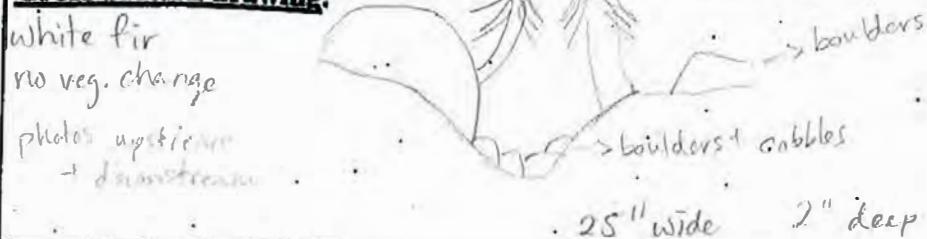
Cross section drawing:

GPS point: D10 This is now D6

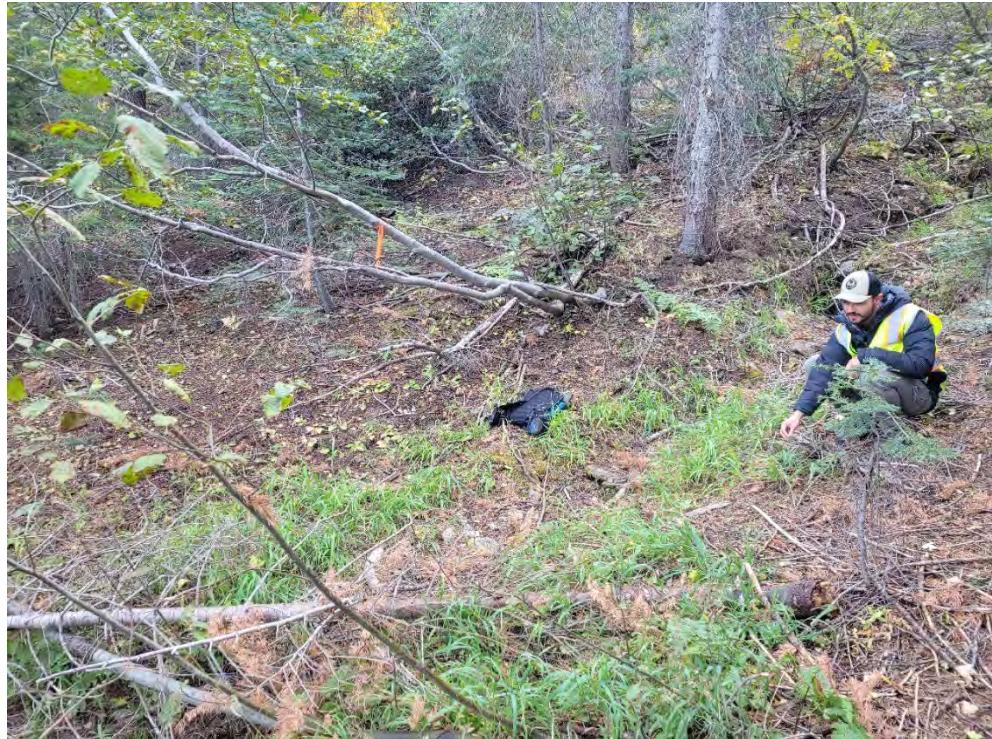
PP 2: D1b, looking east at proposed trail crossing

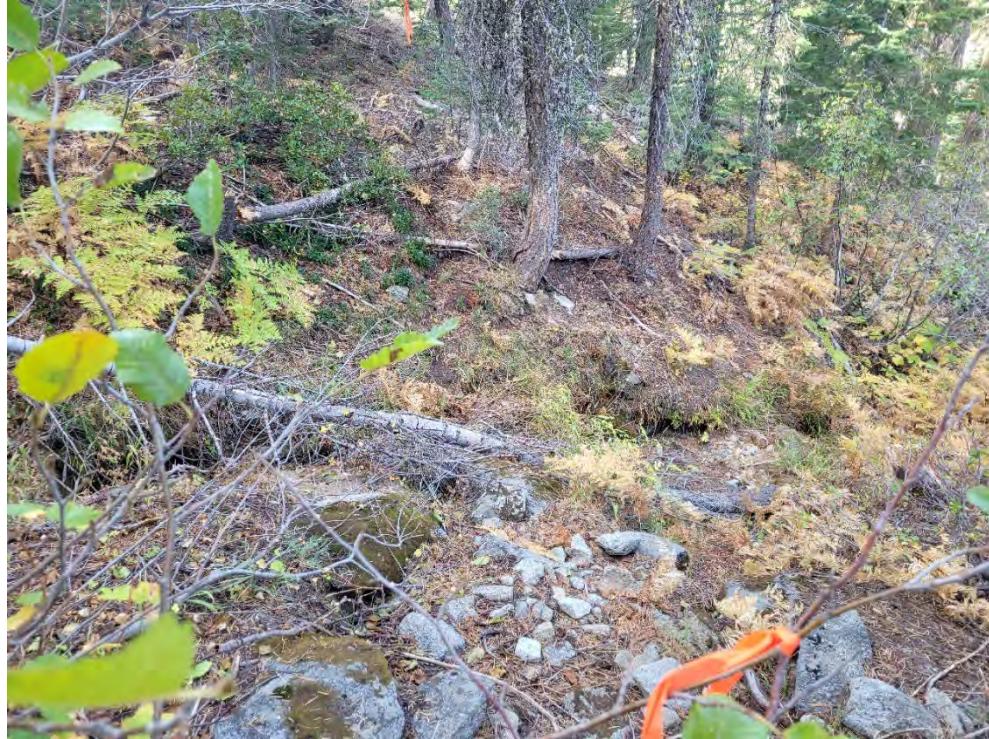
PP 5: D2a, looking west at proposed trail crossing

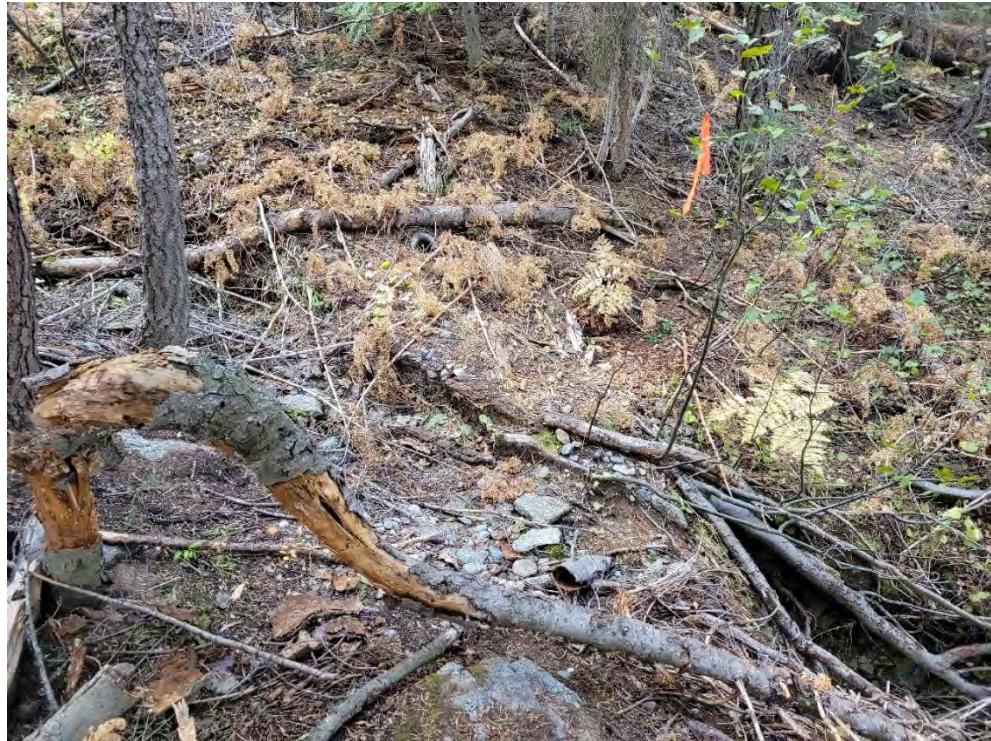
PP 7: D3, looking west at proposed trail crossing

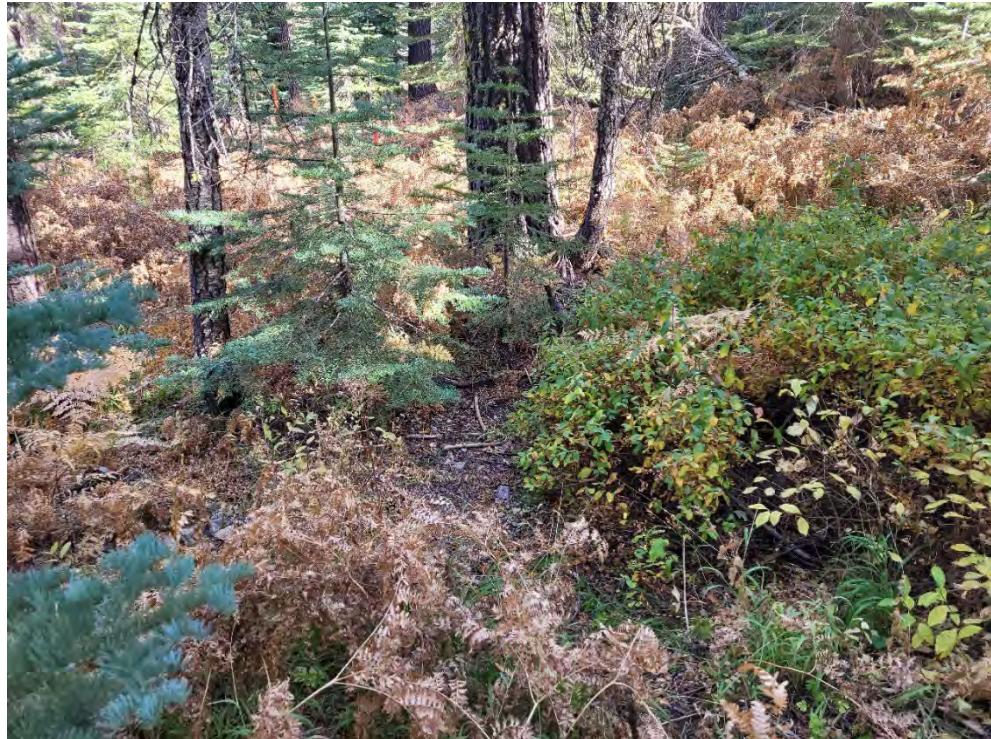
PP 8: D4, looking east at proposed trail crossing

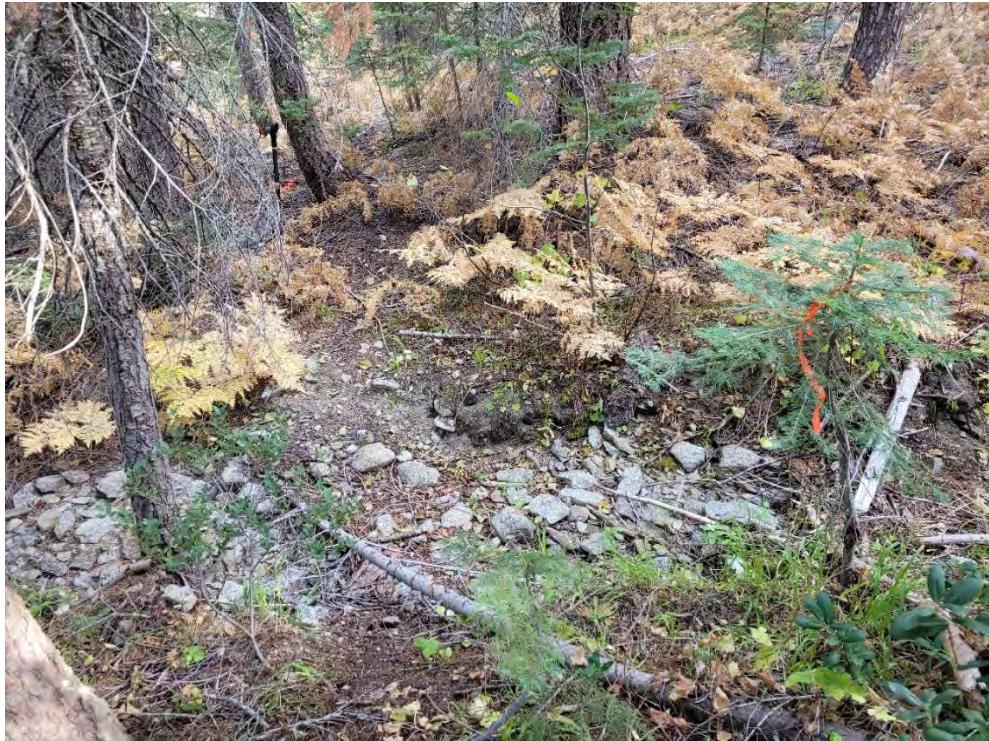
PP 9: D5a, looking northeast at proposed trail crossing

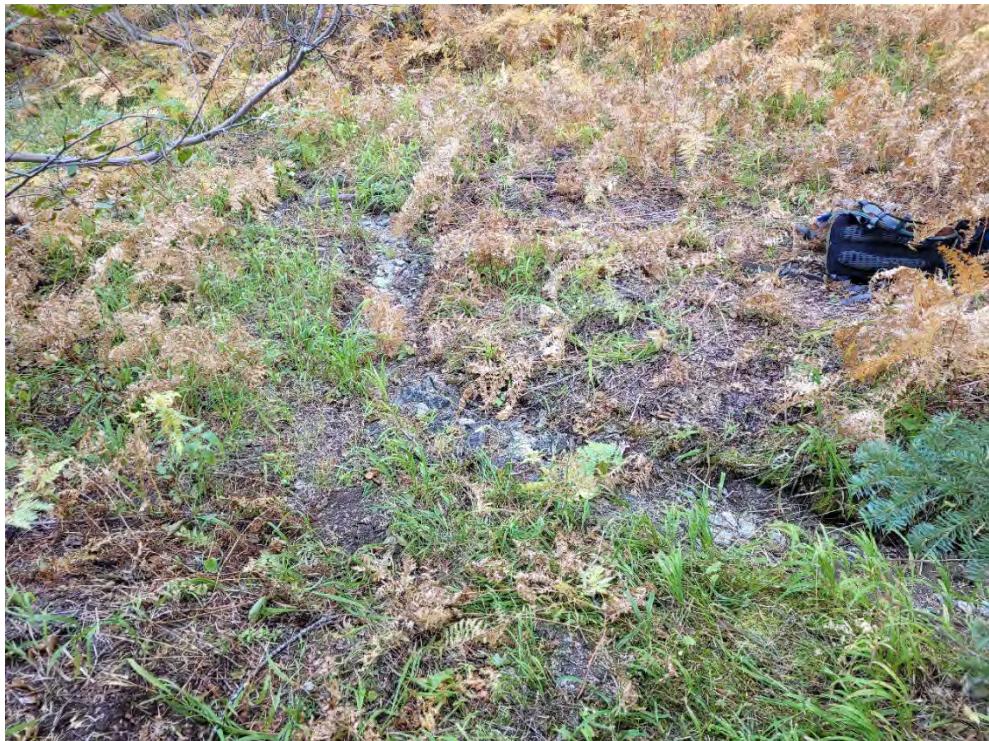
PP 10: D5b, looking northeast at proposed trail crossing
