CORNER RECORD

County of PLUMAS, California

Brief Legal Description Most Southerly Corner of Parcel 2, 7 PM 62, Sec. 9, T. 22 N, R. 12 E, M.D.M.

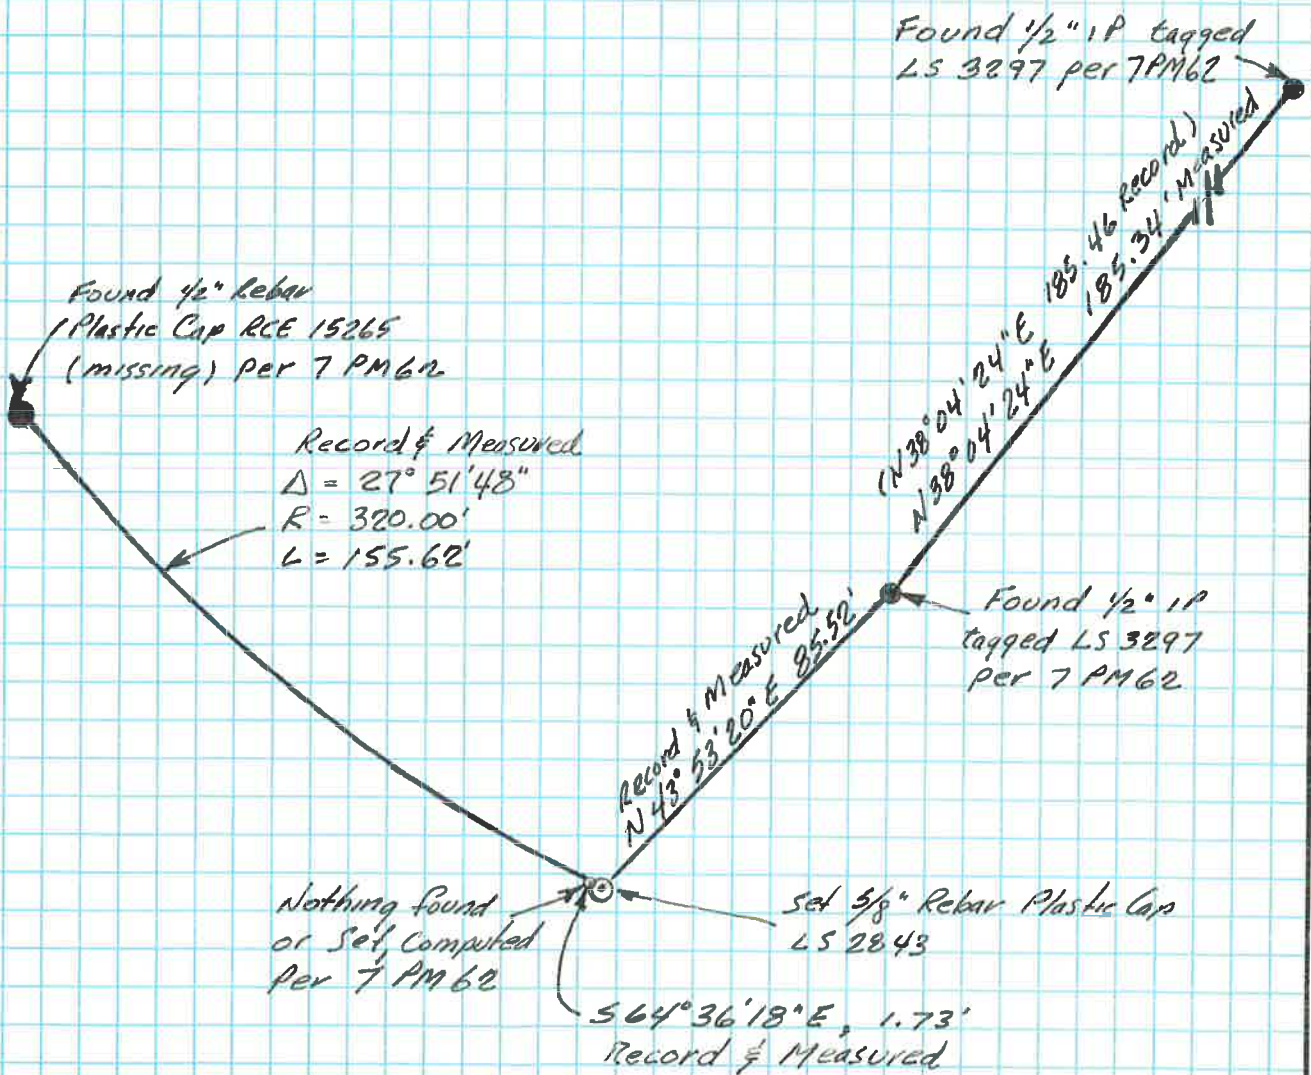
Original corner was a 1/2" IP tagged LS 3297 per 7 PM 62, appeared to have been set on edge of ditch, which was probably destroyed when ditch was cleaned. Reestablished corner in record position from found 1/2" IP, tagged LS 3297, to North and found 1/2" Rebar (Plastic Cap RCE 15265 per 7 PM 62 missing) to West

A description of the physical condition of the monument as found and as set or reset: Set 5/8" Rebar

with Plastic Cap LS 2843 on edge of ditch in record position from found points.
