CORNER RECORD

Document Number 99Portion of Section 6, T. 23 N., R. 14 E., M.D.M. County of Plumas, California
Brief Legal Description Northwest corner Lot 34, Crocker Mountain Estates, 3 M 44

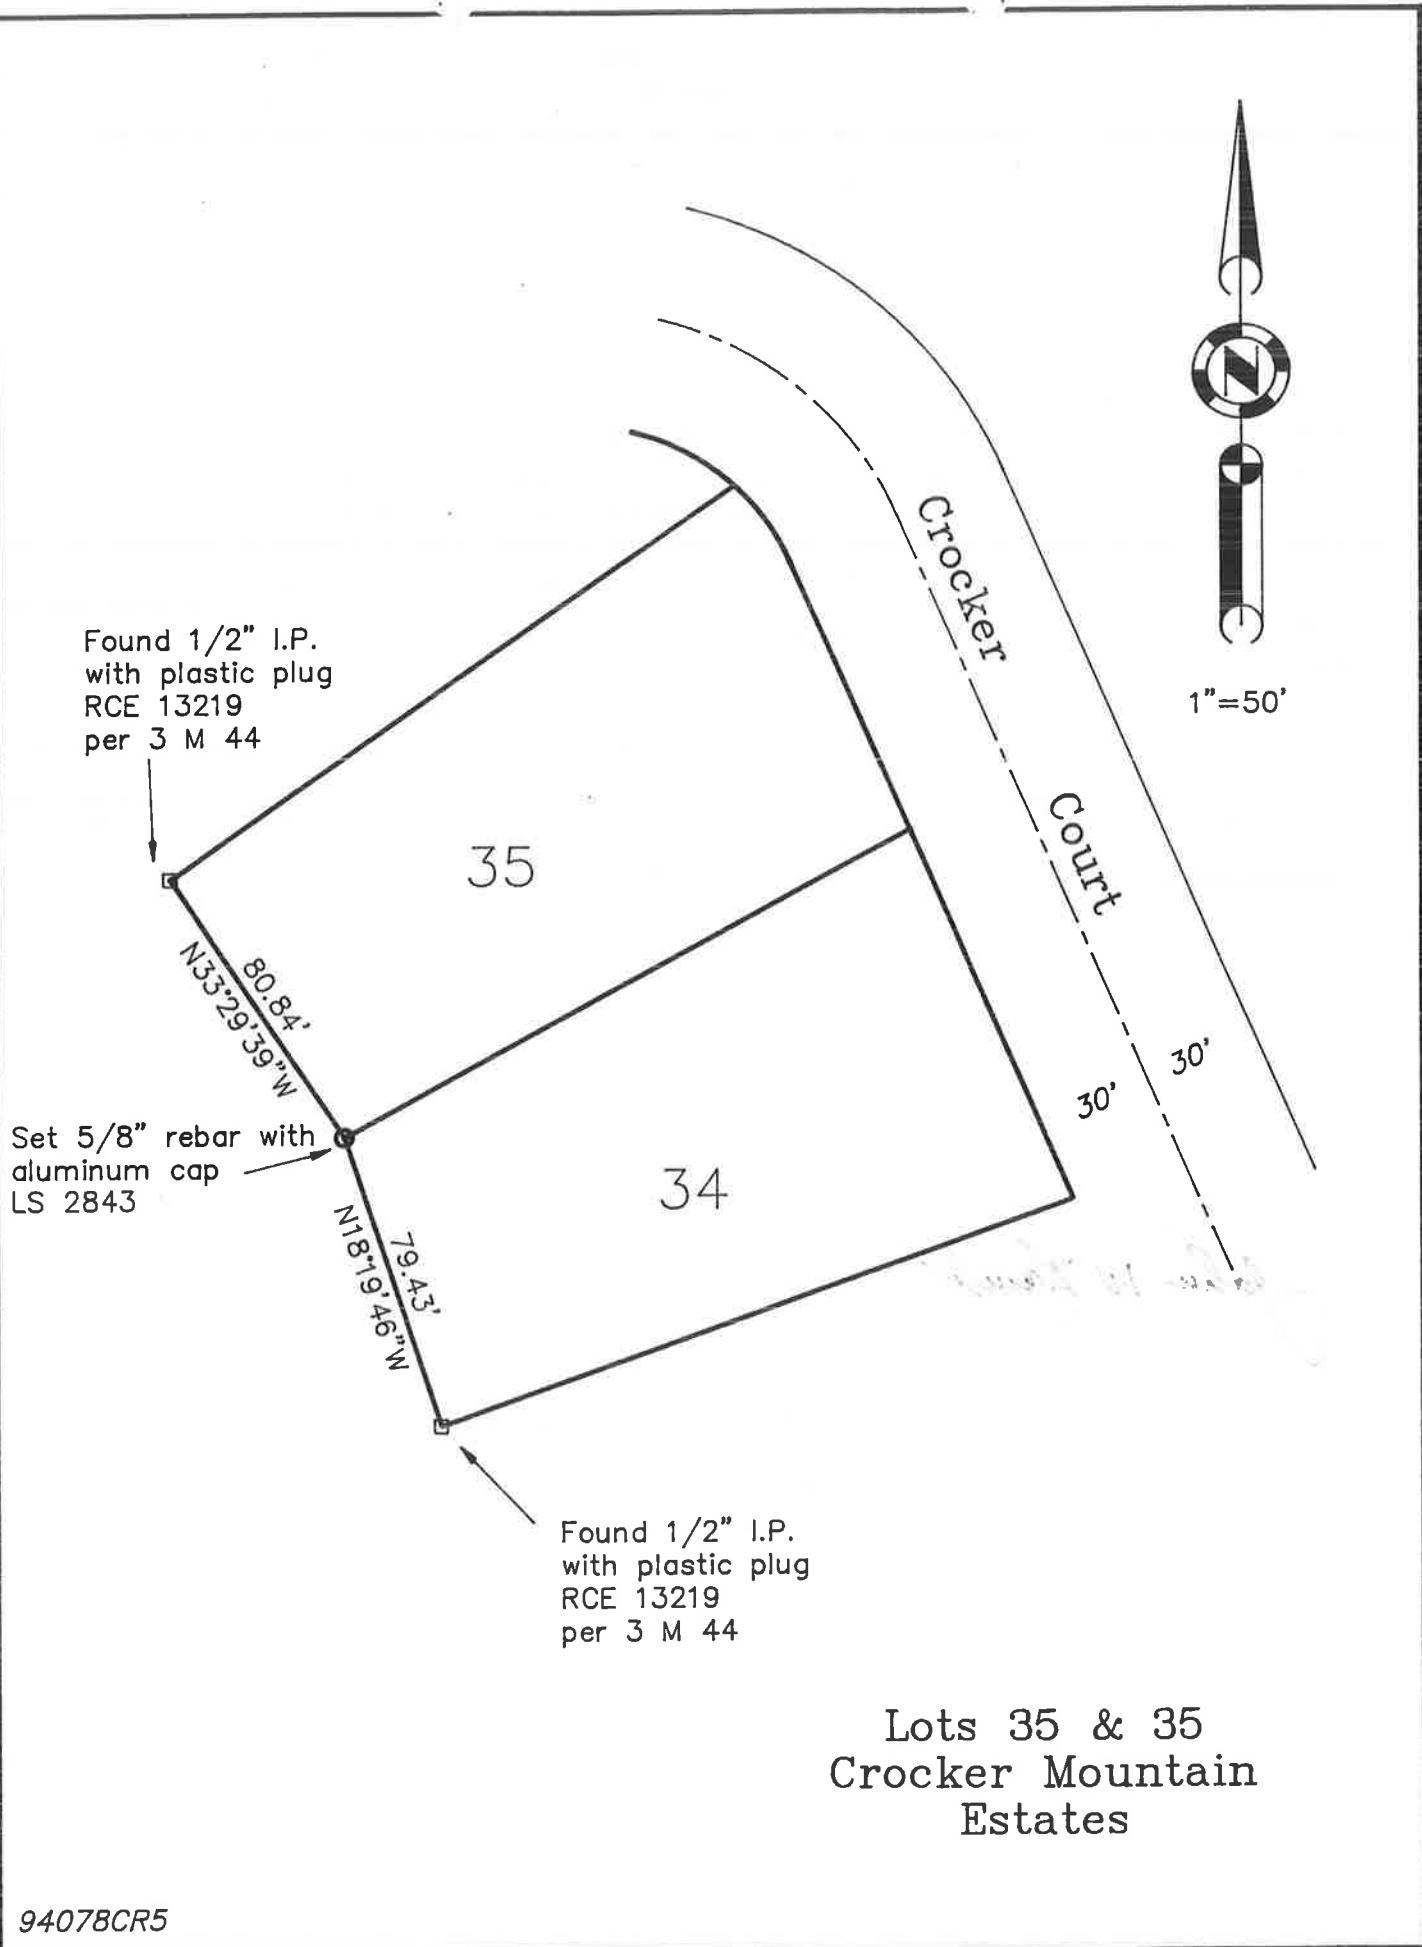
Identification and type of corner found: Evidence used to identify or procedure used to establish or reestablish the corner:
Found 1/2" I.P. with plastic plug RCE 13219 at the Northwest corner of Lot 35 and the Southwest corner of Lot 34, from which I established the Northwest corner of Lot 34 which is also the Southwest corner of Lot 35.

A description of the physical condition of the monument as found and as set or reset: Set 5/8" rebar with aluminum cap LS 2843 for the Northwest corner of Lot 34 as shown on sketch.
