## CORNER RECORD

NE1/4 SECTION 17, T 22 N, R 13 E., M.D.M.

County of PLUMAS

Brief Legal Description PARCEL 2 OF 12 RS 108 AND PARCEL 3 OF 1 PM 78

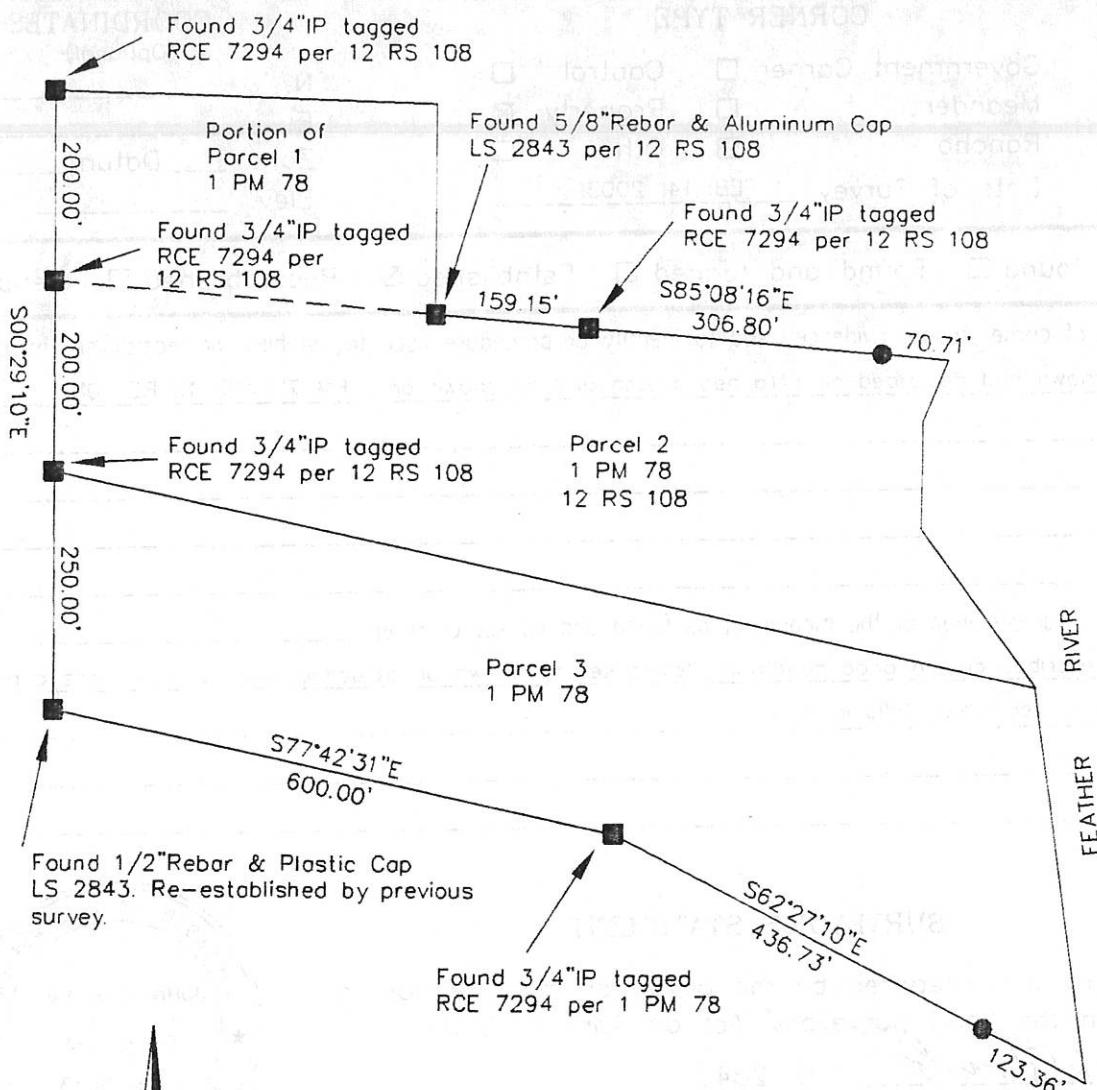
Found points as shown and described on attached sketch and as shown on 1 PM 78 AND 12 RS 108.

Found points as described and in good condition. Points set as shown on attached sketch, as witness corner to actual property corner, which falls in river.

NOTE: ALL DISTANCES ARE RECORD PER 1 PM 78  
AND 12 RS 108
