## CORNER RECORD

Portion Section 4, T.23N.R.10E. MDM

County of Plumas, CaliforniaBrief Legal Description Portion Section 4, T.23N.R.10E

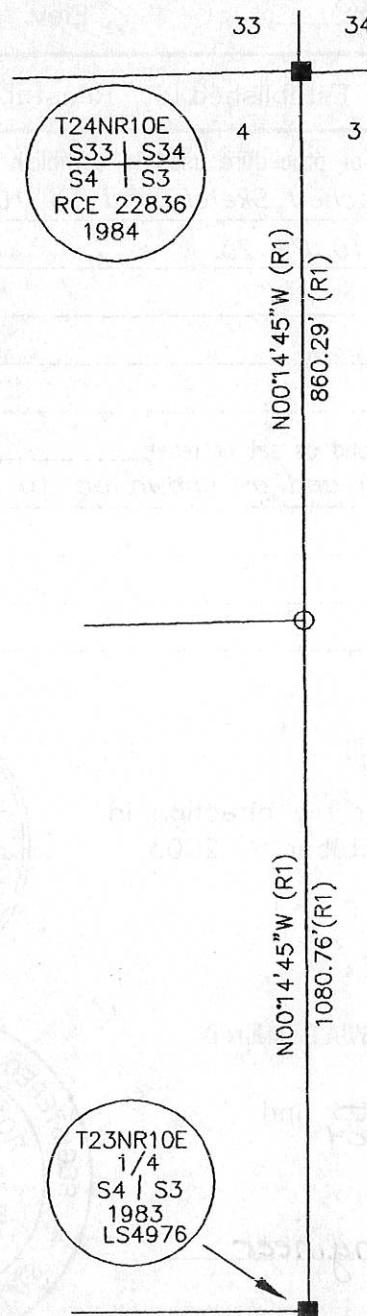
Portion Section 4  
T.23N.R.10E MDM  
Plumas County, Ca.  
Scale 1" = 300'  
November 2003

*Found USFS monuments as shown on the attached Sketch and on 10 RS 73, and  
set the monument in the position shown per 10 RS 73.*

*Found the USFS monuments in good condition and as shown on 10 RS 73.*

- FOUND USFS Aluminum Cap per 10 RS 73
- SET 5/8" Rebar & Aluminum Cap LS 2843
- (R1) RECORD per 10 RS 73
