CORNER RECORD

A portion of N.E.1/4 Section 17, T.21N.R.9E. MDM

County of Plumas, California

Brief Legal Description Lot 108 - Laport Pines Country Club 2 M 71

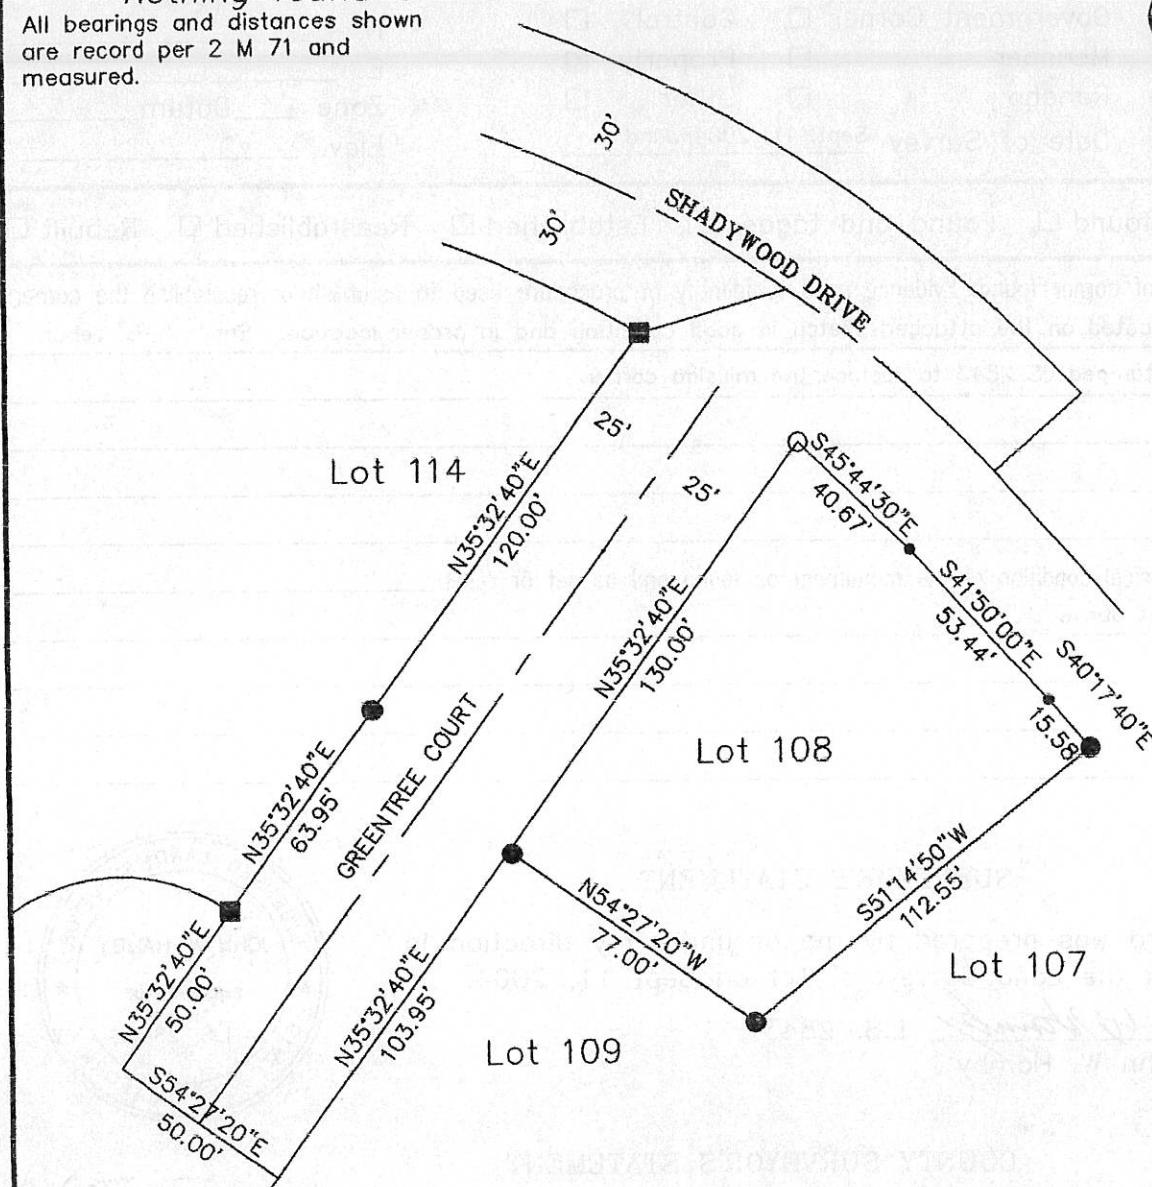
Lot 108
La Porte Pines Country Club
A portion of Section 17,
T.21N.R.9E., M.D.M.
Plumas County, Ca.
Sept. 2004 Scale 1"=50'

Found all points indicated on the attached sketch in good condition and in proper location. Set a 5/8" rebar with aluminum cap stamped LS 2843 to replace the missing corner.

- FOUND 1/2" rebar per 2 M 71
- FOUND 1 " Iron Pipe per 2 M 71
- SET 5/8" Rebar & Aluminum Cap LS 2843
- Nothing found or set

All bearings and distances shown
are record per 2 M 71 and
measured.
