## CORNER RECORD

Document Number 300

Brief Legal Description Lot 1 Claremont Village No. 4 4 M 90

LOT 1  
CLAREMONT VILLAGE No.4  
4 m 90  
Section 24, T.24N.R.9E. MDM  
Scale 1"=100' April, 2004

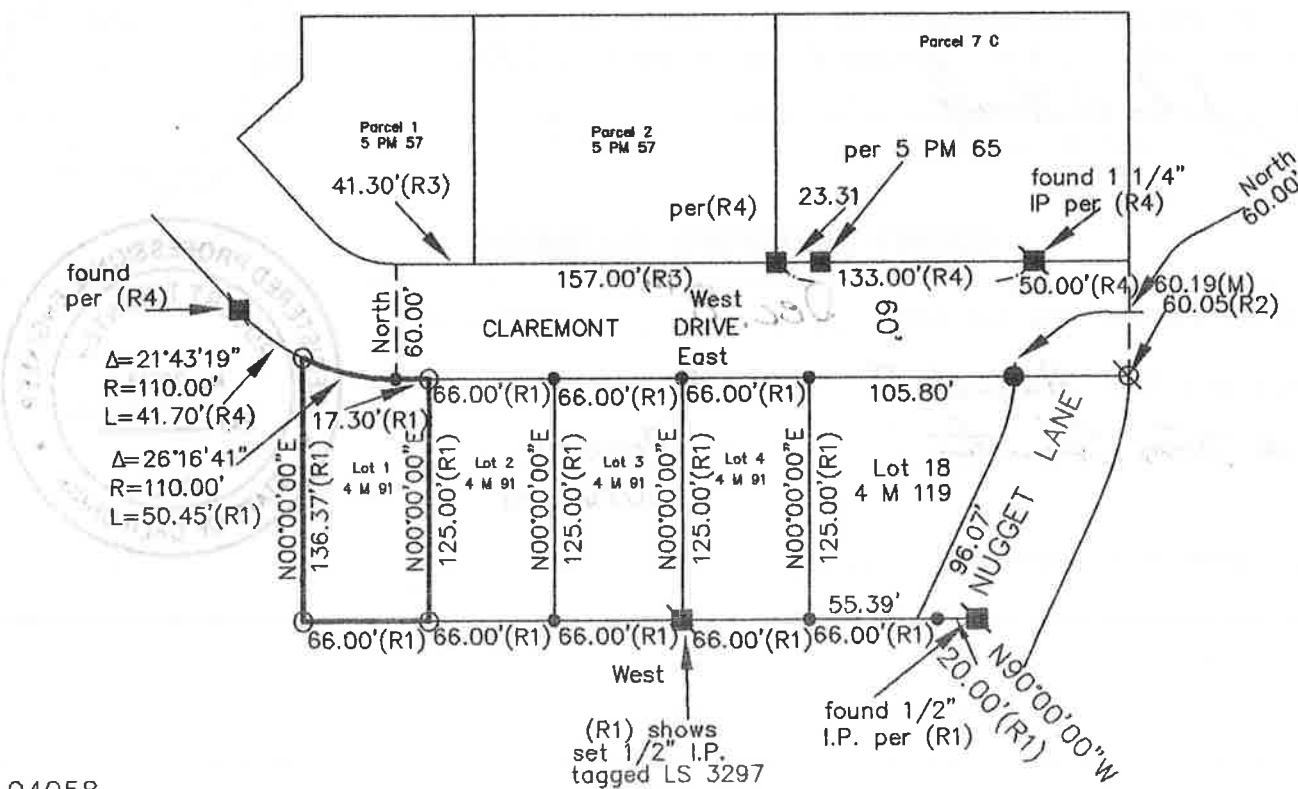
- FOUND 1/2" rebar with Plastic Cap RCE 11173
- FOUND 1/2" Rebar with Plastic Cap LS 3297 per 12 RS 141.
- ❖ FOUND 1/2" Rebar LS 6051 per 12 RS 141.

- SET 5/8" Rebar & Plastic Cap LS 2843

- Nothing found or set

- Found 1/2" rebar

Found points as indicated in good condition

A description of the physical condition of the monument as found and as set or reset:  
Set points as indicated on attached sketch
