CORNER RECORD

Section 10, T. 22 N., R. 13 E., M.D.M.

County of Plumas, California

Brief Legal Description Lot 89, Resubdivision of Iron Horse Rancho Subdivision, 3 M 110

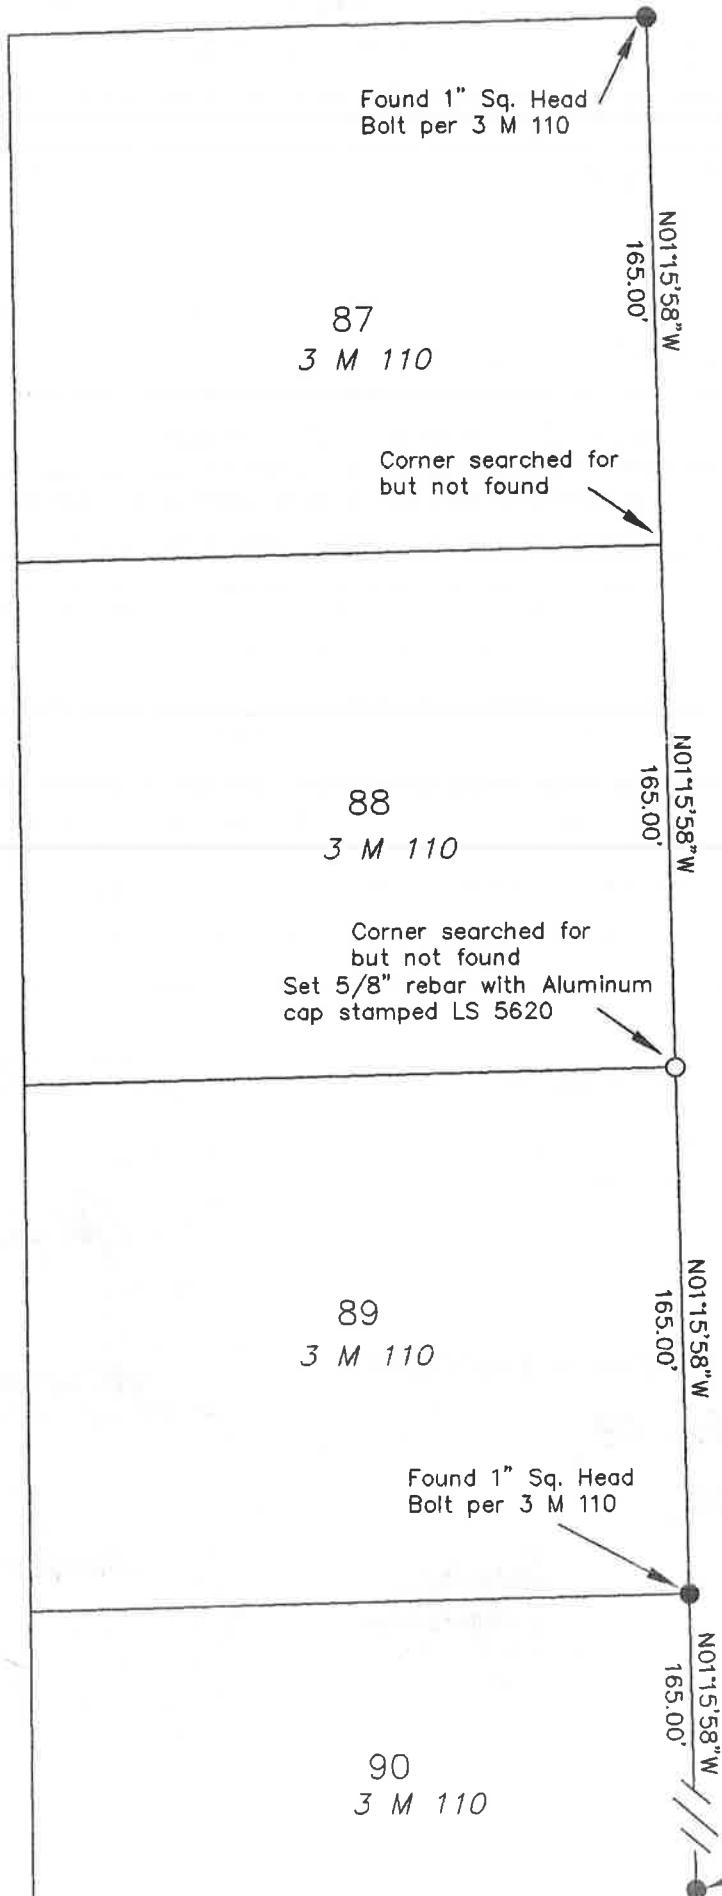
Identification and type of corner found: Evidence used to identify or procedure used to establish or reestablish the corner:
Found 1" sq. head bolts at Northeast corner of Lot 87, Northeast and Southeast corner of Lot 90 in record positions. Corners used to set Northeast corner of Lot 89 as shown on attached sketch.

A description of the physical condition of the monument as found and as set or reset: Set 5/8" rebar with Aluminum cap stamped LS 5620 at Northeast corner of Lot 89 as shown on attached sketch.

Note: All bearings and distances are record per 3 M 110

1" = 60'
