CORNER RECORD

COUNTY OF Plumas T. 23 N R. 7 E MD BEM MERIDIAN CALIFORNIA

SECTION CORNER

CORNER RECORD (SEARCH)

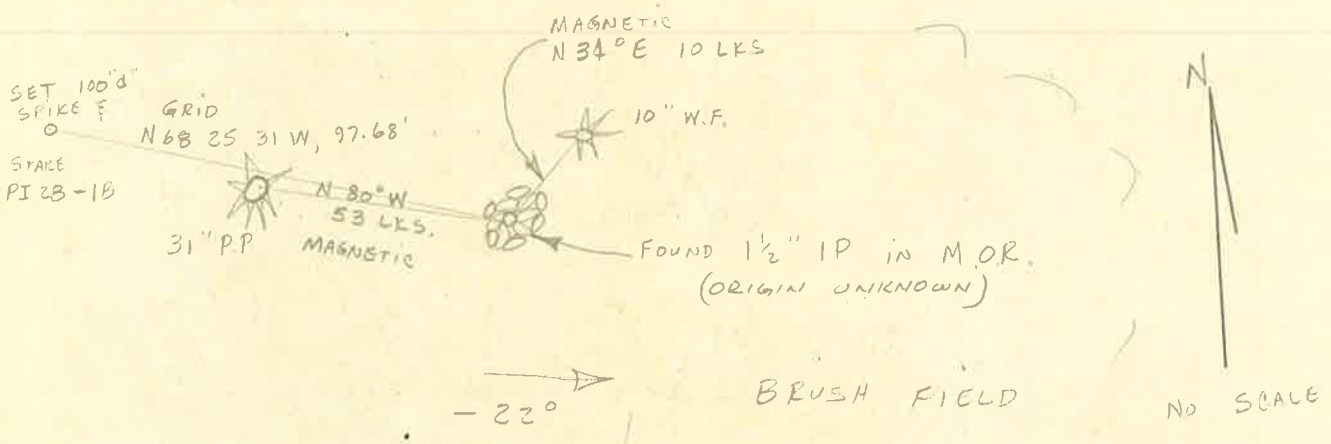
SKETCH: (Include reference tie or witness points, remarks and topo of area)

FOUND $1\frac{1}{2}$ " INSIDE DIAMETER IRON PIPE IN MOUND OF GRANITE ROCK IN A BRUSH FIELD WITH TWO "K" TAGGED AND MARKED BEARING TREES 1. B.T. 31" P.P. N. 80°W. 53 LKS. 2. B.T. 10" W.F. N. 34°E. 10 LKS.

SET A 100" d SPIKE W/ STAKE MARKED PI 28-1B CALIF GRID N 68°25' 31" W 97.68' FROM FOUND CORNER.

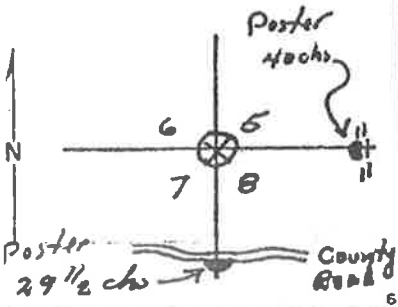
CORNER DIAGRAM

DESCRIBE CORNER MONUMENT FOUND A post was set by original surveyor this is no longer to be found.

1. P.P. 3 1/4" N 80°W 53 lbs. Alive. Grown over.
 2. Manzanita (5") N. 8°E. 4 lbs. Grown.
 3. P.P. (1") S. 45°W. 16 lbs Grown.
 4. P.P. (3") S. 48°E. 10 lbs Grown.
- Mound of stone located around point.

Corner in brush field. B.T. visible from county road. Posters as shown in sketch.
