CORNER RECORD

Document Number 336

County of Plumas, California

Brief Legal Description Centerline of River per 2 RS 112 as shown on 10 RS 21

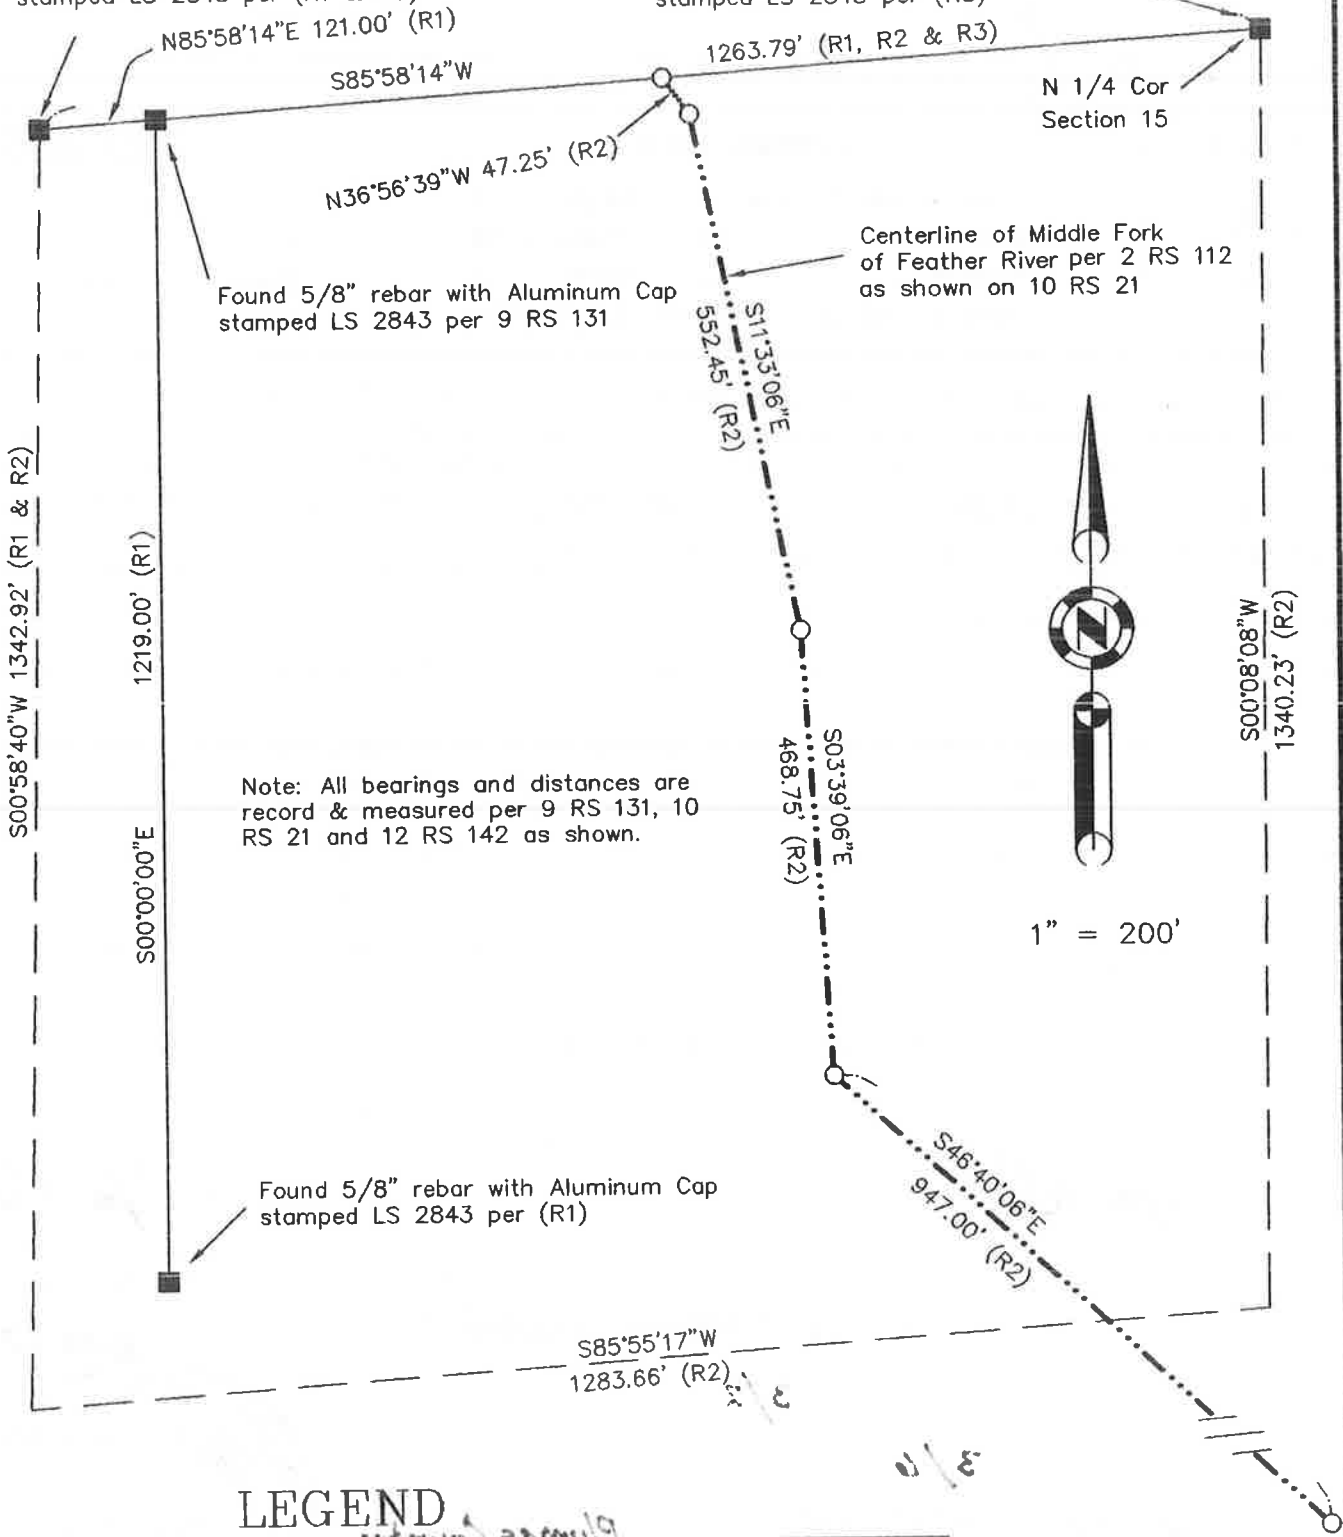
Identification and type of corner found: Evidence used to identify or procedure used to establish or reestablish the corner:
Found corners per 9 RS 131, 10 RS 21 and 12 RS 142 which were used to set the corners shown on 10 RS 21 as shown on attached sketch.

A description of the physical condition of the monument as found and as set or reset: Set 5/8" rebar with Aluminum Cap stamped LS 5620 as shown on attached sketch.

Found 5/8" rebar with Alum. Cap stamped LS 2843 per (R1 & R2)

Found 5/8" rebar with Aluminum Cap stamped LS 2843 per (R3)

Found 5/8" rebar with Aluminum Cap stamped LS 2843 per 9 RS 131

Centerline of Middle Fork of Feather River per 2 RS 112 as shown on 10 RS 21
