CORNER RECORD

Document Number 357

County of Plumas, California

Brief Legal Description Lot 1 & 2, 12 PM 13 - Section 35, Township 23 N. Range 16 E.

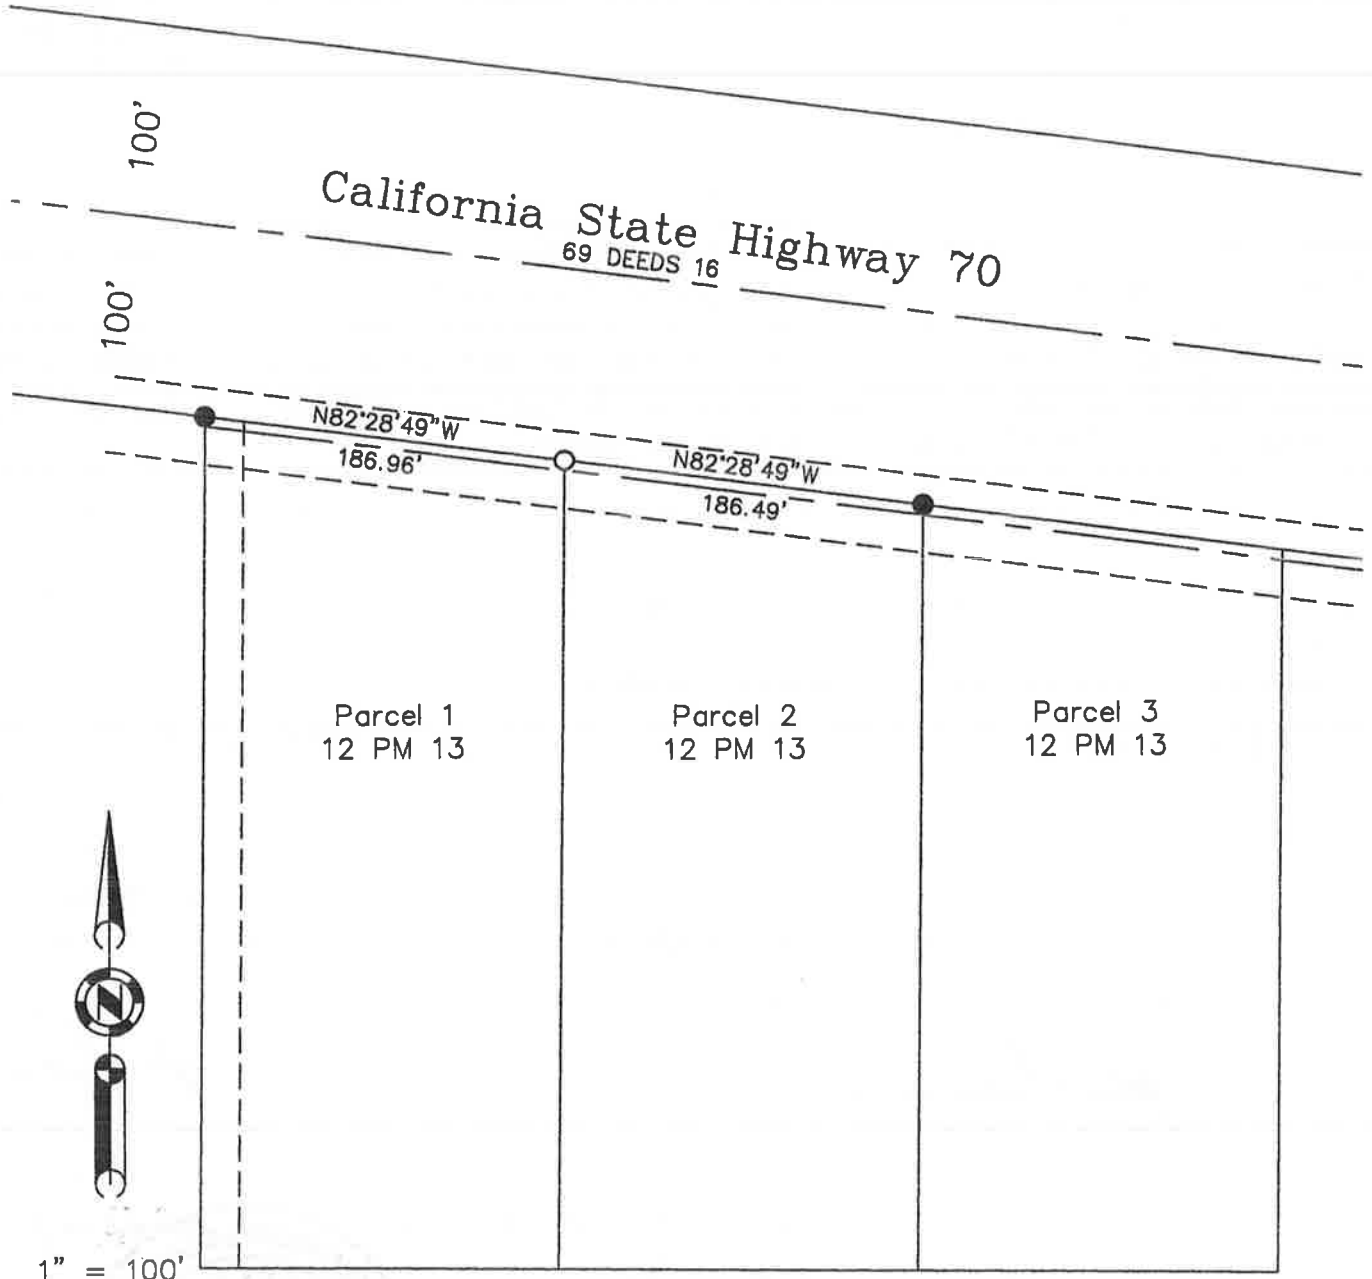
Identification and type of corner found: Evidence used to identify or procedure used to establish or reestablish the corner:  
Found Northwest corner of Parcel 1 and Northeast corner of Parcel 2 in good condition per 12 PM 13 as shown on attached sketch.

A description of the physical condition of the monument as found and as set or reset:  
Original corner was destroyed by road construction.  
Reset the Northerly corner common to Parcels 1 & 2 in record position as shown on sketch.

Bearings and Distances shown are Record and Measured per Book 12 of Parcel Maps at Page 13.
