CORNER RECORD

City of near Whitehawk County of Plumas, California
 Brief Legal Description South-South 1/64th, S2 & S1, T21N, R12E Mount Diablo Meridian

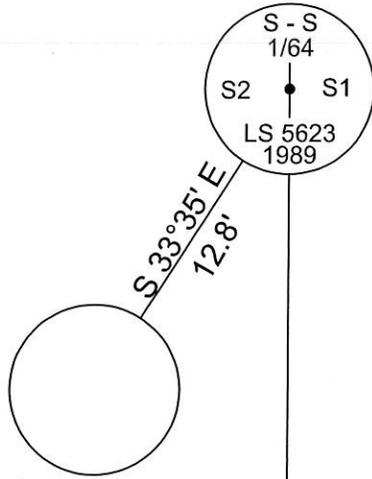
The Southwest-Southwest 1/64 Witness Corner of Section 1 was destroyed and has not been reestablished hereon.

Set new bearing tree, a 15" White Forked Fir, blazed and scribed "XBT", etched 6" ring 6' above ground, painted blaze and ring red. Mag Spikes for bearing and distance, 54-3 sign. 54-9 sign on back of tree.

599.27' MEASURED AND RECORD PER 9RS107
