RECORD OF SURVEY

for EASTERN PLUMAS RURAL FIRE PROTECTION DISTRICT

A portion of Lot 1 of LAKEVIEW SUBDIVISION

A portion of Section 11
T. 23 N., R. 13 E., M.D.M.

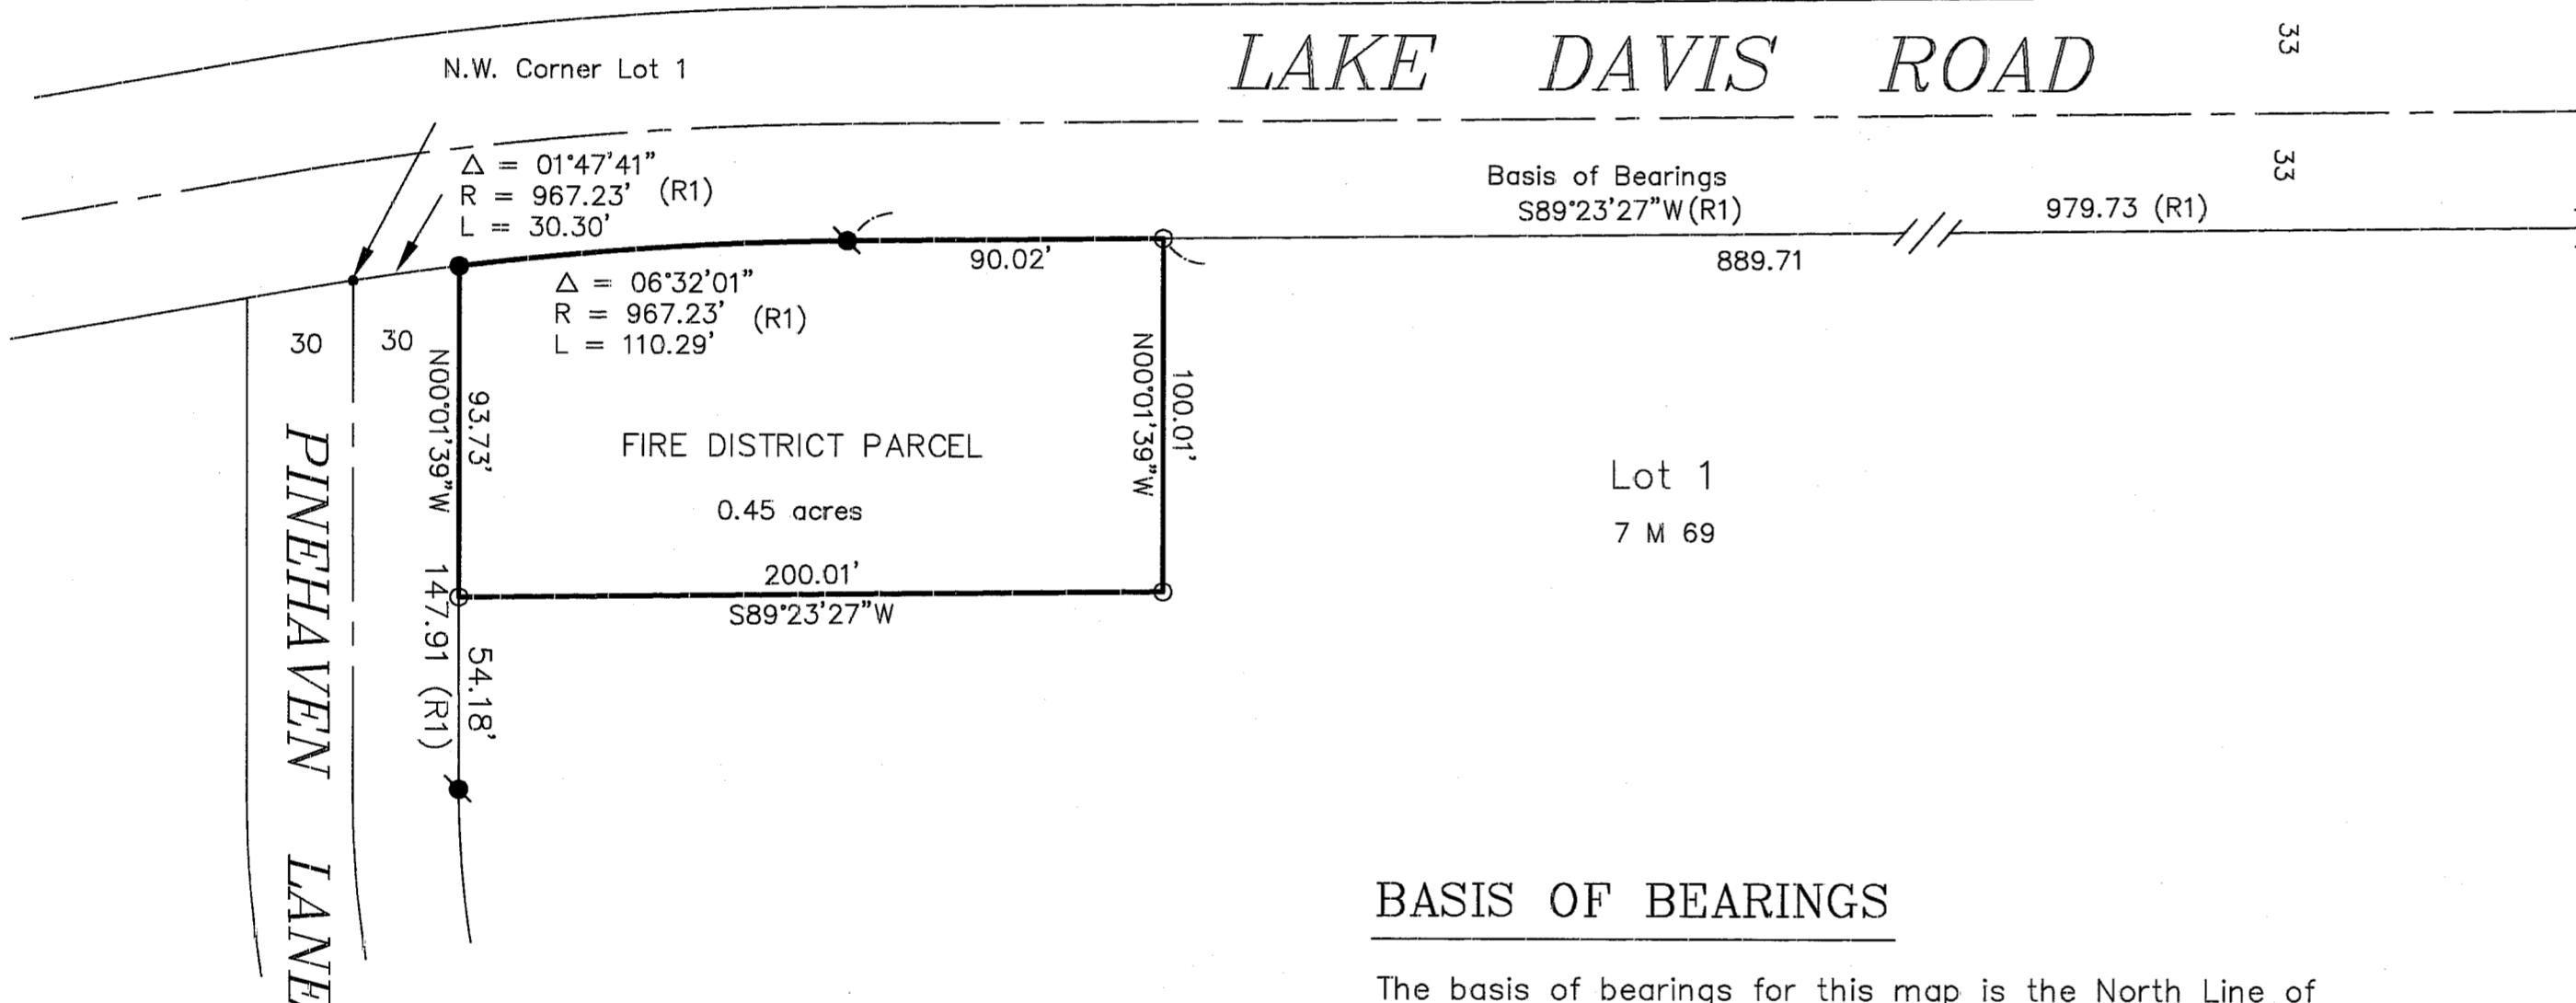
BASIS OF BEARINGS

The basis of bearings for this map is the North Line of Lot 1, shown as N89°23'27"E on the Map of LAKEVIEW SUBDIVISION, filed in the office of the Recorder of Plumas County in Book 7 of Maps at page 69.
